Construction Impact Assessment and Management Plan

Cranbrook Senior School

Prepared For: Architectus Design Studio.

Dated: October, 2019.

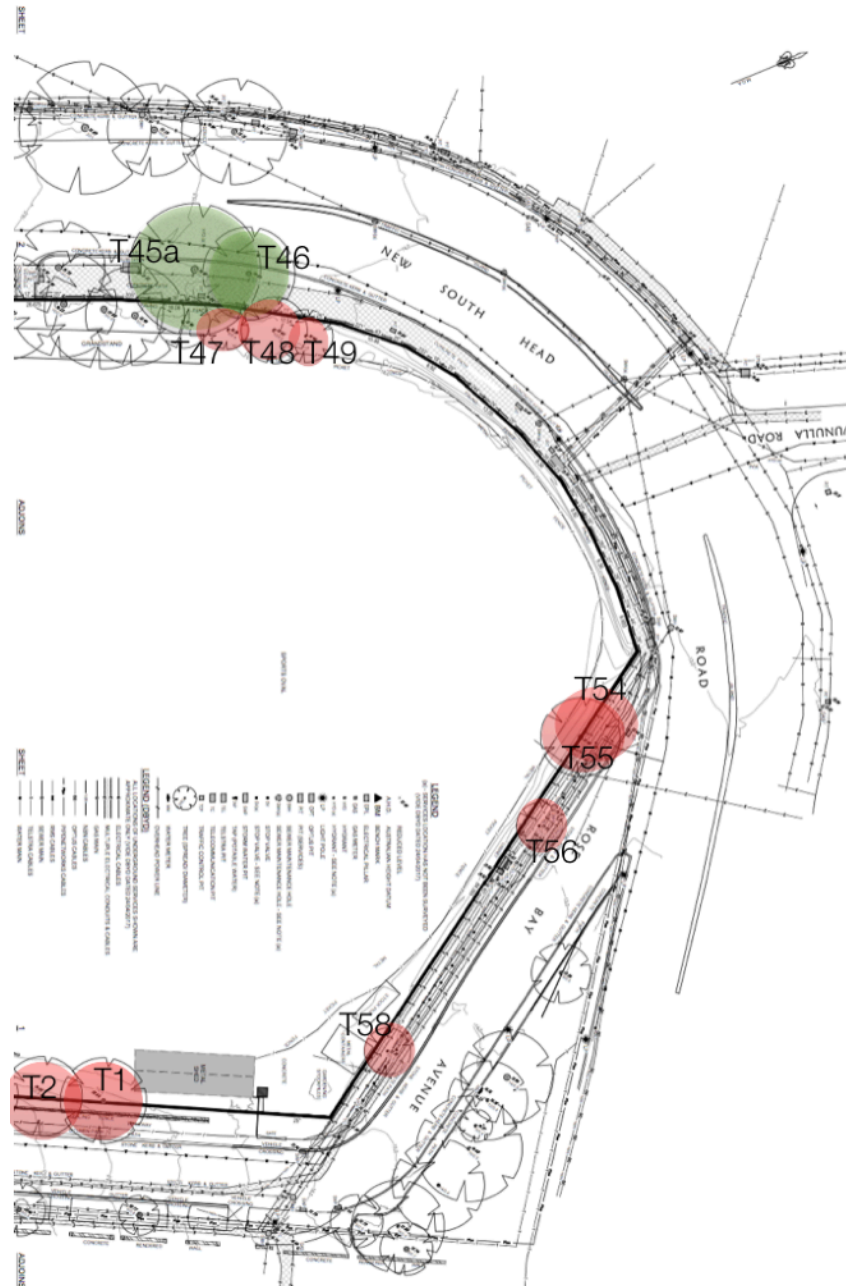
Figure 1 Shows the trees being retained and removed.

8.1 This report will recommend the retention of Trees 3, 4, 5, 6, 7, 8, 9, 10, 11, 12, 13, 36, 39, 40, 41, 42, 43, 44, 45, 45a and 46. These will be retained via the implementation of the following list of recommendations. These have been based on our national standard for the *Protection of Trees on Development Sites AS4970*.

8.2 Removal recommendations have been made for the following trees based their location in relation to the construction. Additional removal recommendations have been made based on poor species characteristics and structure. These include Trees 1, 2, 14, 15, 16, 17, 18, 19, 20, 20a, 21, 22, 23, 24, 25, 26, 27, 28, 29, 30, 31, 32, 33, 34, 35, 37, 38, 45a, 47,48, 49, 50, 51, 52, 53, 54, 55, 56, 57.

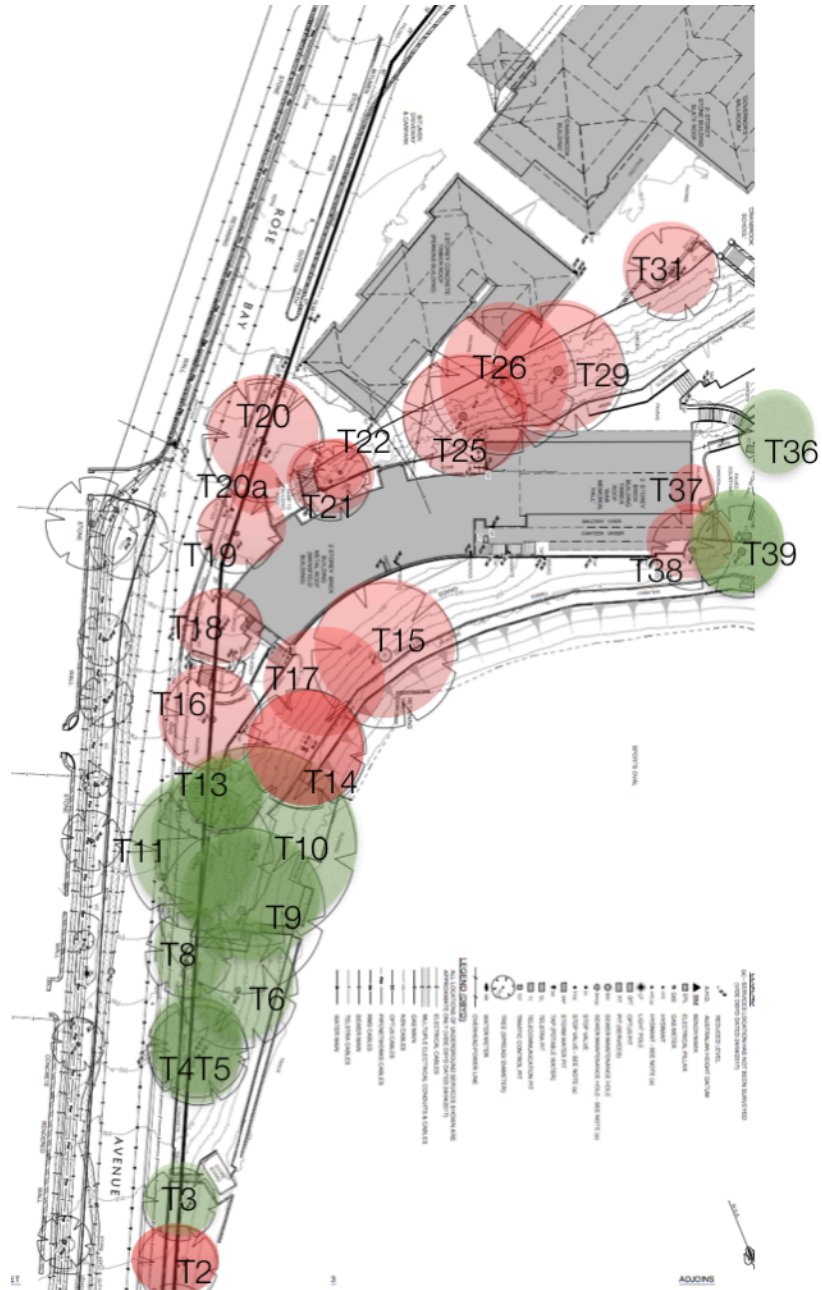
Figure 2 Shows the trees being retained and removed.

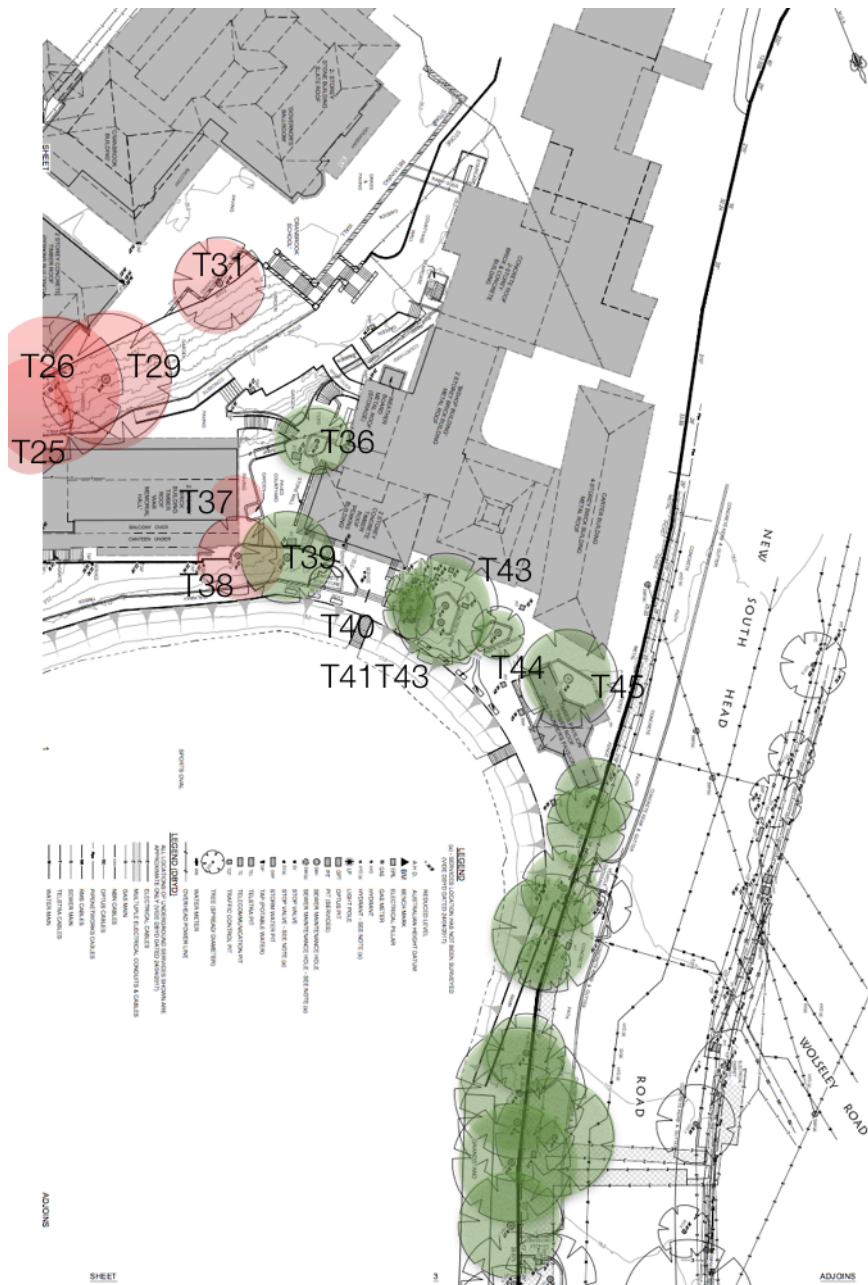
Figure 3 Shows the trees being retained and removed.
