Pre-Construction Dilapidation & Photographic Survey of RMS Infrastructure Rose Bay Avenue and New South Head Road

DATE	30/10/2019
TO	EPM Projects Pty Ltd
ATTN	Mr Michael Nasiry
PROJECT	Cranbrook School Stage 2 Project
APPLICANT	Cranbrook School
APPLICATION NO.	SSD 8812

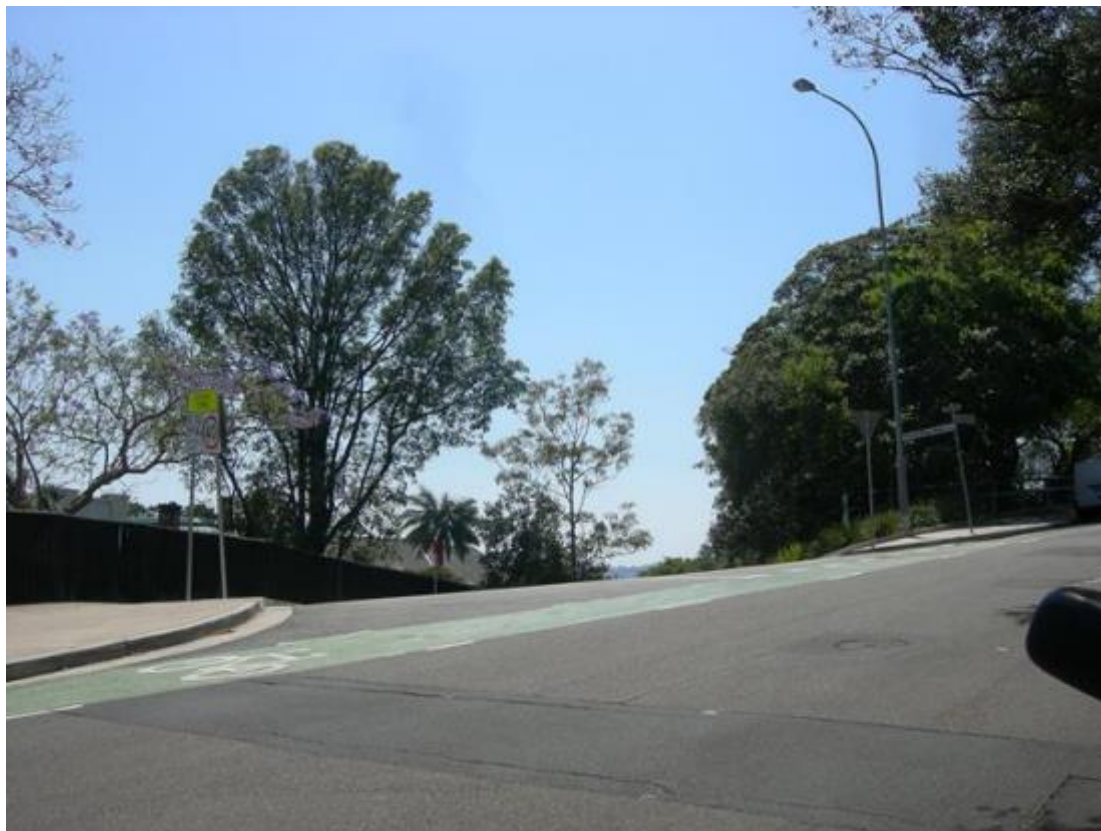
PHOTO 1

PHOTO NO	OBSERVATION
1 to 3	Indentations, cracks and localised pitting observed at Rose Bay Ave near Victoria Rd intersection
4	Crack at footpath at west of Rose Bay Ave near Victoria Rd intersection
5	Joints, indentations and tyre marks along north bound lane of Rose Bay Ave near Victoria Rd intersection
6	Eastern boundary fence of the school along Rose Bay Ave near Victoria Rd intersection
7	Cracks and holes at west footpath of Rose Bay Ave
8	Cracks and indentations along north bound lane of Rose Bay Ave
9	Wide cracks along west footpath of Rose Bay Ave
10 & 11	Joints, cracks and indentations along north bound lane of Rose Bay Ave
12 & 13	Broken kerb and wide cracks along west footpath of Rose Bay Ave. Also, school fence noted to be broken and out of plumb
14	Along north bound lane of Rose Bay Ave cracks, indentations and localised pitting observed
15 & 17	Broken and out of plumb timber fence at west footpath of Rose Bay Ave

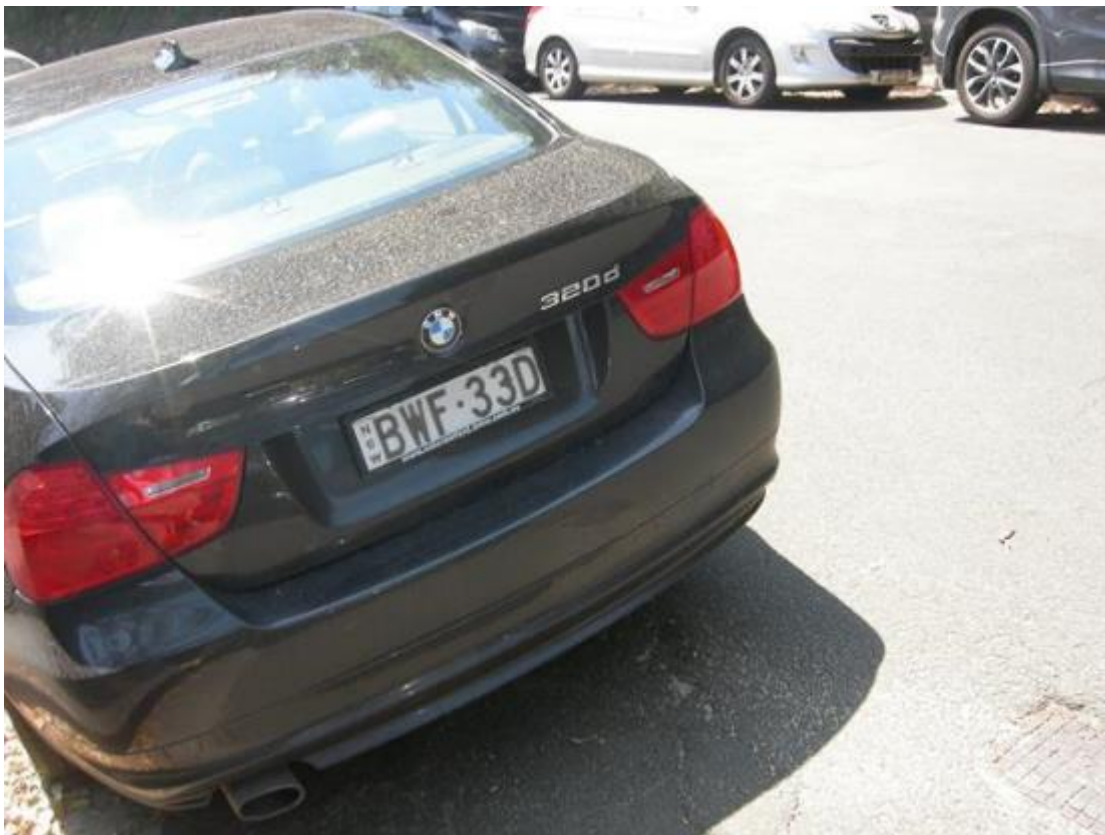
PHOTO 16

16	Localised pitting and cracks at parking lane at west of Rose Bay Ave
18	Cracks at footpath and broken kerb & gutter at west of Rose Bay Ave
19	Along north bound lane of Rose Bay Ave cracks, indentations and localised pitting observed

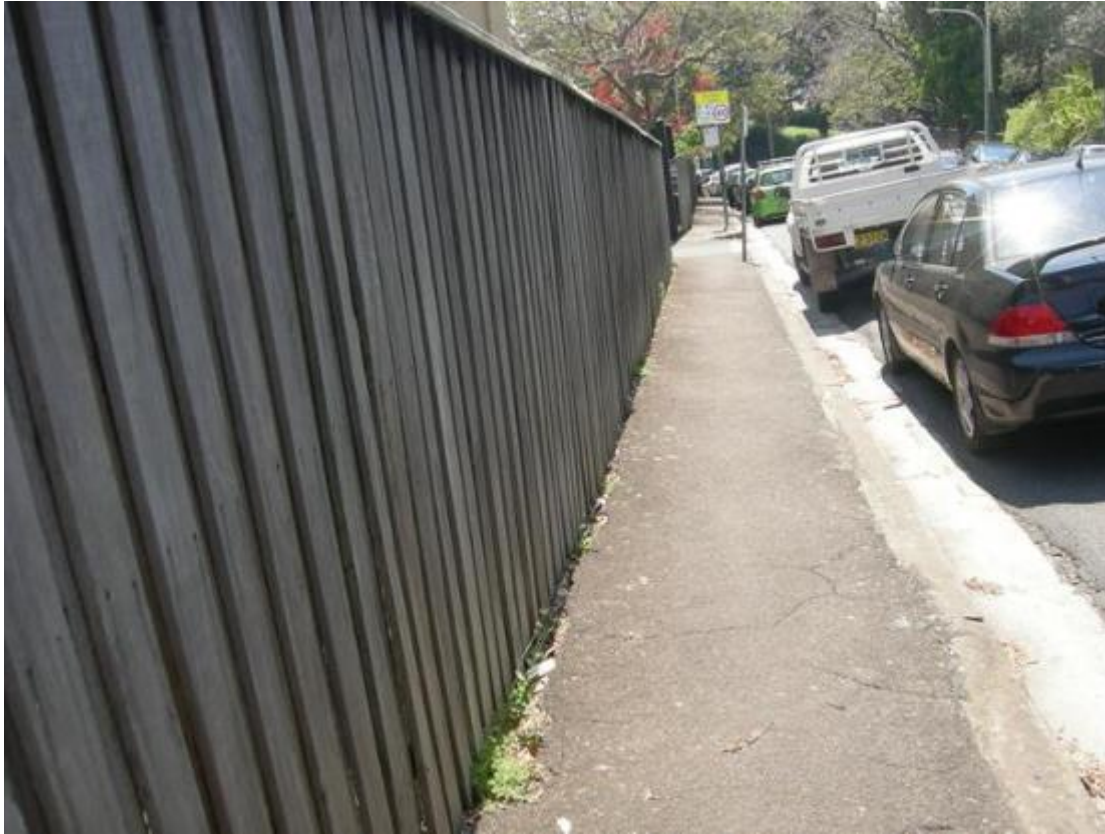
PHOTO 23

PHOTO NO	OBSERVATION
20	Wide cracks along west footpath of Rose Bay Ave
21 & 22	Along north bound lane of Rose Bay Ave cracks, indentations and localised pitting observed
23	Broken kerb and wide cracks along west footpath of Rose Bay Ave. Also, school fence noted to be out of plumb
24	Tyre marks, cracks, indentations and localised pitting along north bound lane of Rose Bay Ave
25 to 32	Cracks at footpath, broken kerb & gutter and out of plumb timber fence at west of Rose Bay Ave
33	Along north bound lane of Rose Bay Ave cracks, indentations and localised pitting observed
34 to 38	Cracks at footpath, broken kerb & gutter and broken & out of plumb timber fence at west of Rose Bay Ave
39	Along north bound lane of Rose Bay Ave cracks, indentations and localised pitting observed
40 to 47	Cracks at footpath, broken kerb & gutter and broken & out of plumb timber fence at west of Rose Bay Ave
48 to 50	Along north & south bound lanes of Rose Bay Ave cracks, indentations and localised pitting noted

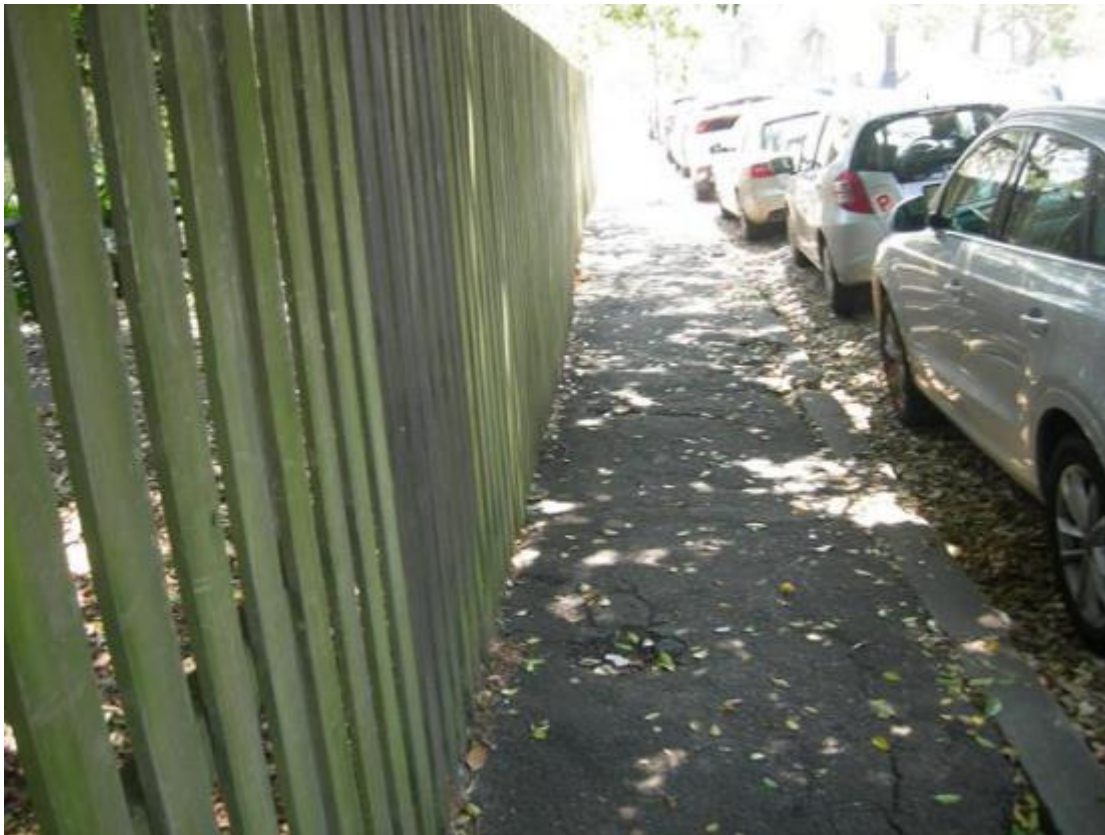
PHOTO 51

51 to 54	Cracks at footpath, broken kerb & gutter and broken & out of plumb timber fence at west of Rose Bay Ave
55	Along north bound lane of Rose Bay Ave cracks, indentations and localised pitting observed
56 to 59	Holes & Cracks at footpath and broken kerb & gutter at west of Rose Bay Ave
60 to 62	Along north & south bound lanes of Rose Bay Ave cracks, indentations and localised pitting noted
63 to 64	Wide Cracks at footpath and broken kerb & gutter at west of Rose Bay Ave
65 to 66	Uneven settlement, cracks, indentations and localised pitting noted along north & south bound lanes of Rose Bay Ave
67 to 72	Cracks at footpath, broken kerb & gutter and out of plumb timber fence at west of Rose Bay Ave
73 to 79	Along north & south bound lanes of Rose Bay Ave cracks, indentations and localised pitting noted near New South Head Rd intersection
80 to 82	Uneven settlement, wide cracks, broken kerb & gutter noted at west of Rose Bay Ave near New South Head Rd intersection

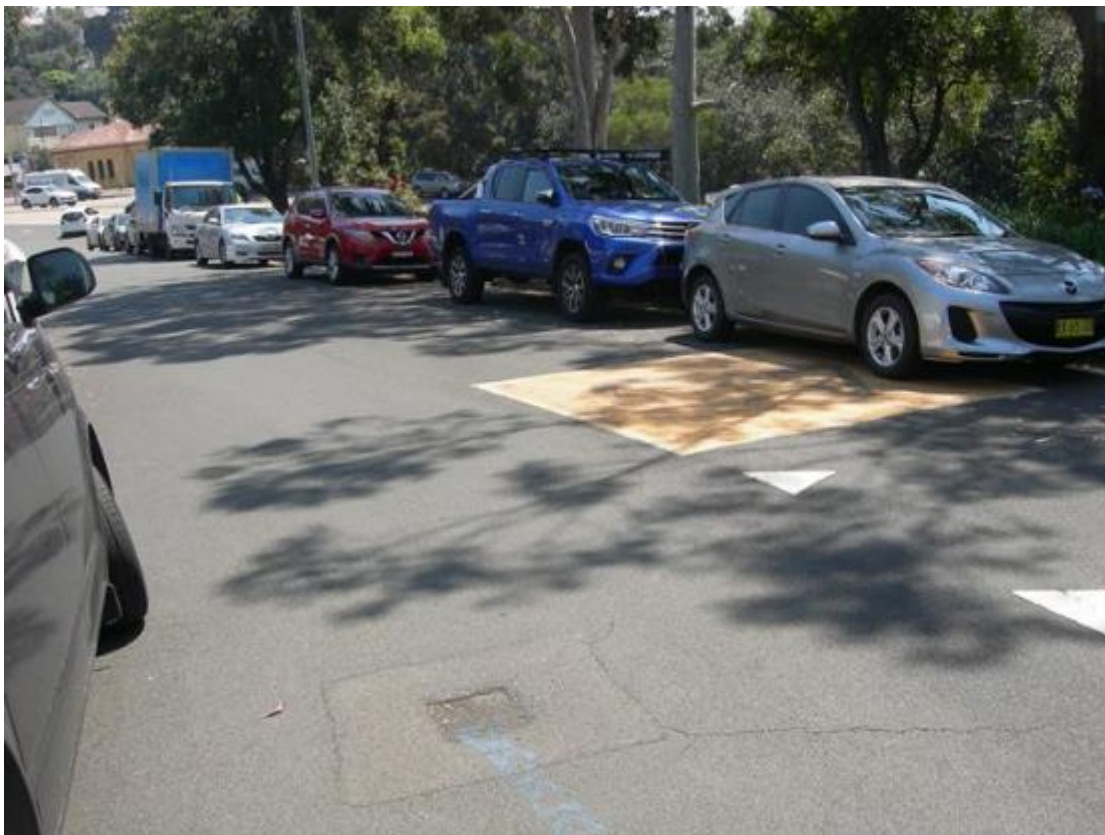
PHOTO 88

PHOTO NO	OBSERVATION
88	Along north bound lane of Rose Bay Ave cracks, indentations and localised pitting noted near New South Head Rd intersection
89	Missing timber fence at west of Rose Bay Ave near New South Head Rd intersection
90 to 93	Along north & south bound lanes of Rose Bay Ave cracks, indentations and localised pitting noted near New South Head Rd intersection
94 to 96	At Rose Bay Ave near New South Head Rd intersection broken kerb at west footpath and cracks, indentations and pitting along north bound lane noted
97 to 98	Telstra Pit and Electrical Pillar at west of Rose Bay Ave near New South Head Rd intersection
99 to 103	At Rose Bay Ave near New South Head Rd intersection broken kerb at west footpath and cracks, indentations and pitting along north bound lane noted
104 to 105	Looking north, joints, uneven surface, indentations and cracks at New South Head Rd near intersection of Rose Bay Ave

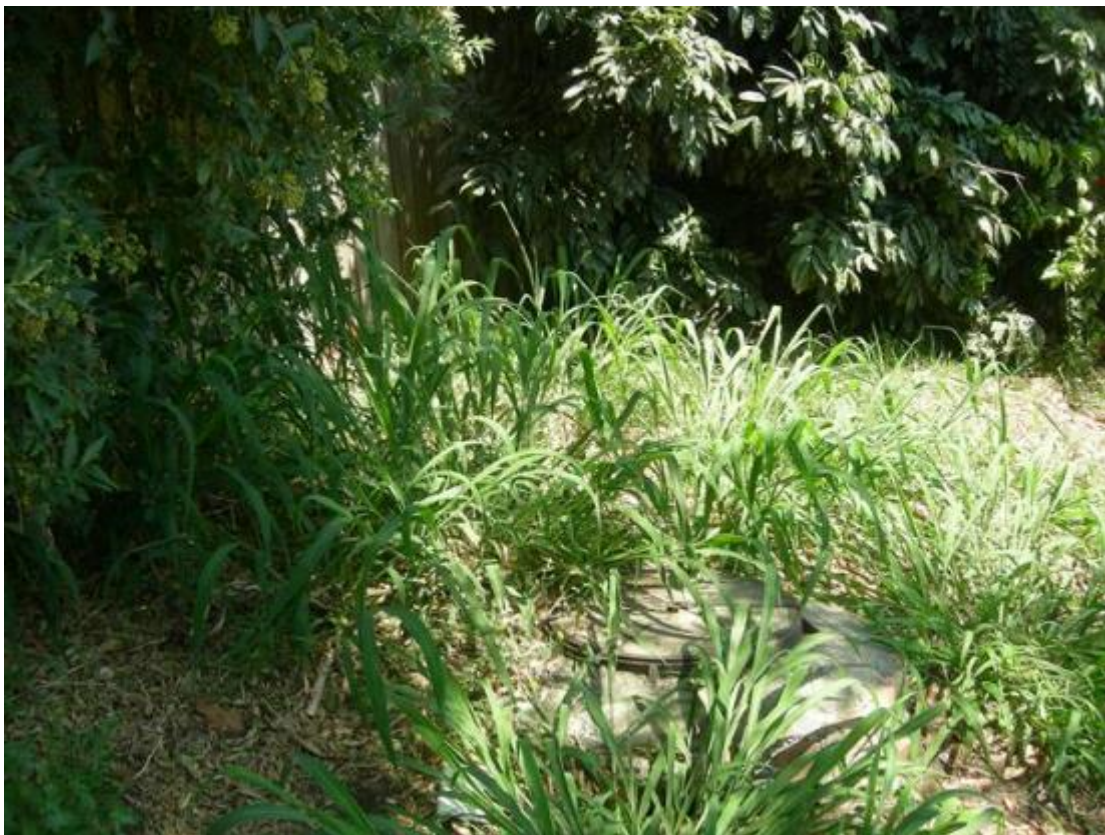
PHOTO 106

106	Man-hole at footpath near intersection of New South Head Rd & Rose Bay Ave
107 to 111	At Rose Bay Ave near New South Head Rd intersection broken kerb at west footpath and cracks, indentations and pitting along north bound lane noted
112 to 114	Along west bound lane of New South Head Rd near Rose Bay Ave intersection cracks indentations and localised pitting observed. Also, cracked kerb & gutter noted.
115	Broken timber fence at south of New South Head Rd
116 to 120	Along west bound lane of New South Head Rd intersection cracks indentations and localised pitting observed. Also, cracked kerb & gutter noted.
121 to 125	Light poles, service pits, footpath and kerb & gutter along south footpath of New South Head Rd
126 to 129	Looking west at New South Head Rd, cracks at footpath and kerb & gutter noted. Along roadway repair patches, cracks, joints, indentations and localised pitting observed along west bound lane

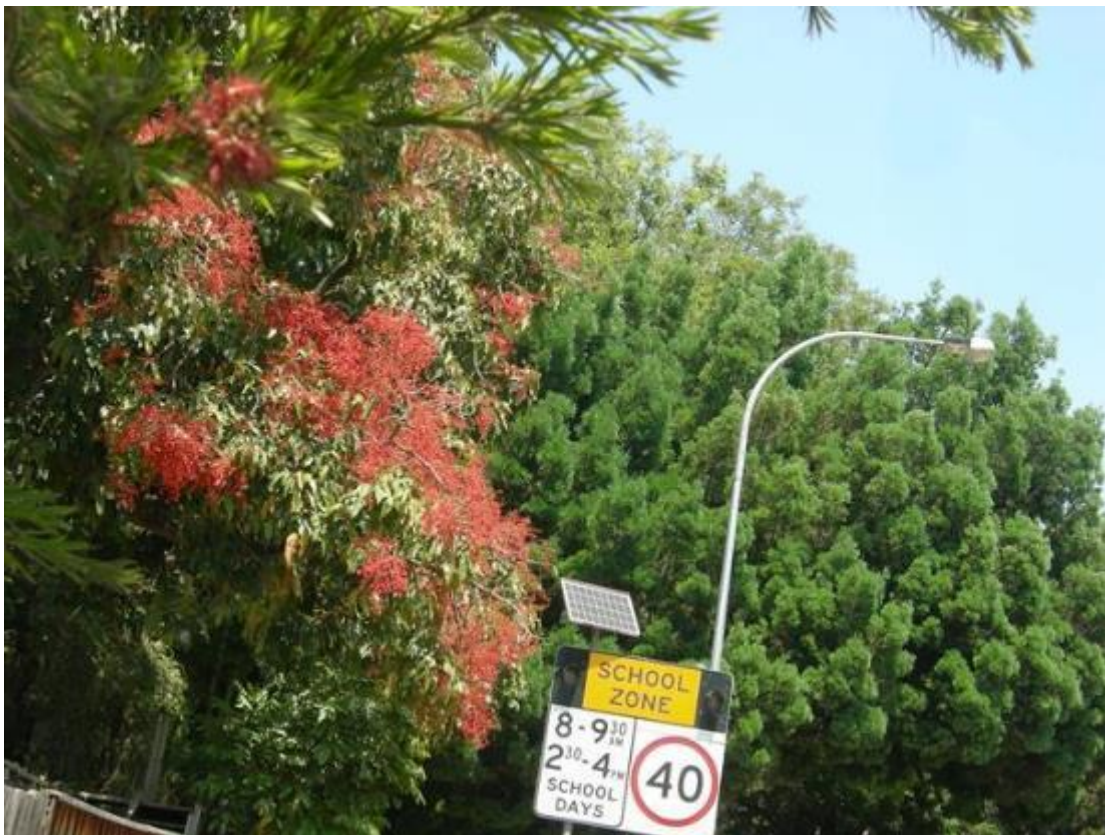
PHOTO 130

130	School Zone sign board at New South Head Rd
131	Cracked roadway along west bound lane, New South Head Rd
132	Broken timber fence at south of New South Head Rd
133 to 134	Uneven footpath and broken timber fence at south of New South Rd
135	Looking north cracked roadway, repair patches and indentations along west bound lane of New South Head Rd
136	Broken kerb & gutter at south of New South Head Rd
137	Looking north uneven roadway, repair patches and indentations along west bound lane of New South Head Rd
138	Electrical Pillar at southern footpath of New South Head Rd
139	Crack at west bound lane of New South Head Rd
140 to 142	Uneven and cracked driveway

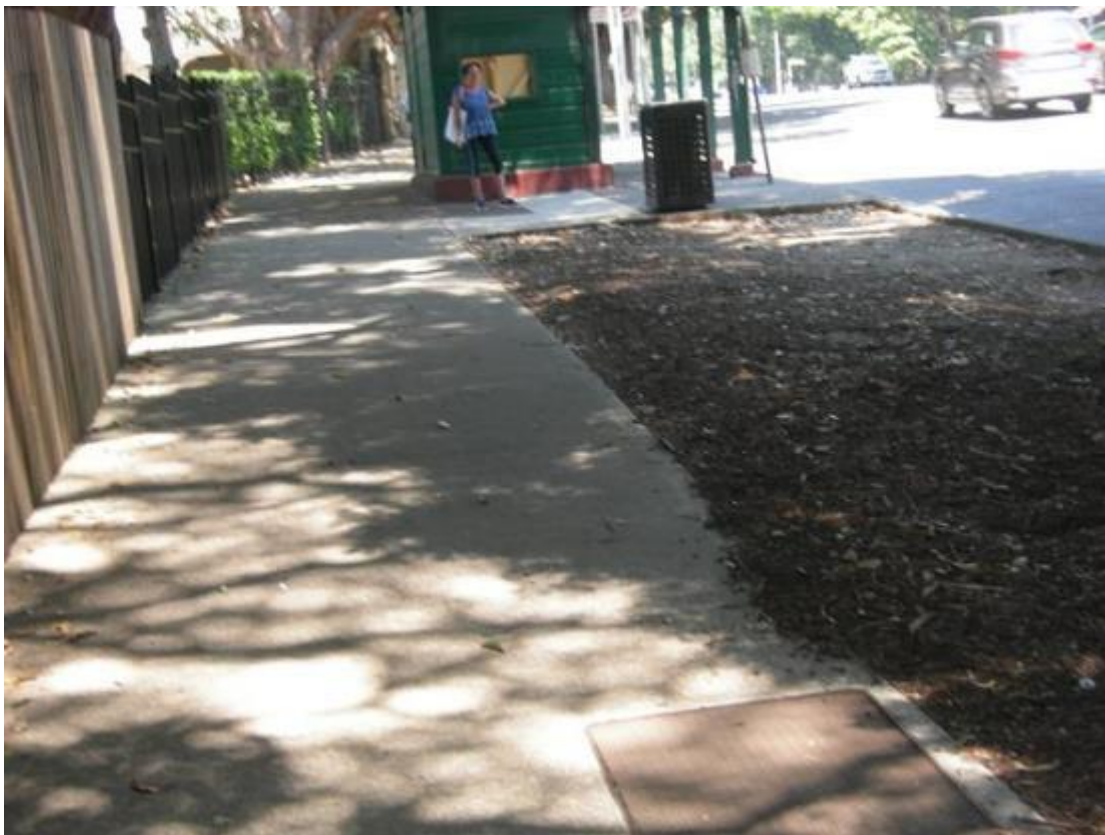
PHOTO 146

PHOTO NO	OBSERVATION
143 to 144	Cracks and indentations at west bound lane of New South Head Rd
145	Uneven kerb at south near bus shelter, New South Head Rd
146	General view of footpath at south near bus shelter at New South Head Rd
147	Cracks, localised pitting and indentations at west bound lane of New South Head Rd
148	Metal fence along south of New South Head Rd
149	Cracked footpath near bus shelter, New South Head Rd
150	View of footpath at backside of bus shelter
151 to 152	Broken concrete pad and cracks at bus shelter, New South Head Rd
153 to 154	Timber roof framing at bus shelter, New South Head Rd
155	Timber Wall framing at bus shelter, New South Head Rd
156	Looking north cracks, indentations and repair patches at west bound lane in front of bus shelter, New South Head Rd
157 to 159	Cracked and uneven footpath & driveway near bus shelter, New South Head Rd
160	General view of tiled roof at bus shelter, New South Head Rd
