INDEPENDENT ENVIRONMENTAL AUDIT REPORT

Cranbrook School, 5 Victoria Road, Bellevue Hill NSW

23 August 2021

19256 R4

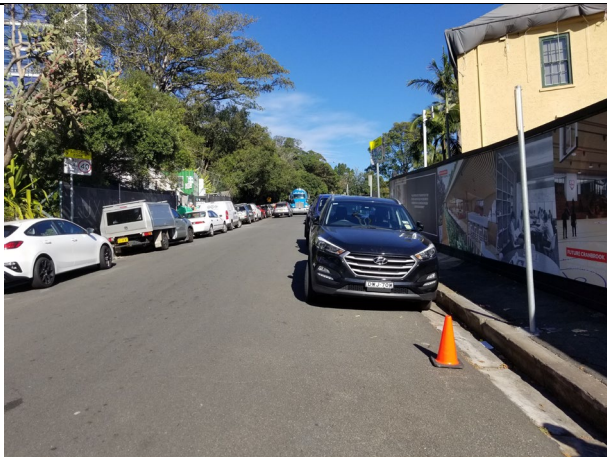
Z64, Z89, Z93, Z143, 165, Z166.	2/6/2021	
<p>Description: No construction vehicle parked on road, noting the blue concrete truck pictured is on the road about to enter the site.</p> <p>No waste, refuse, materials, skips were observed on the road.</p> <p>No tracking of sediment on public roads.</p>

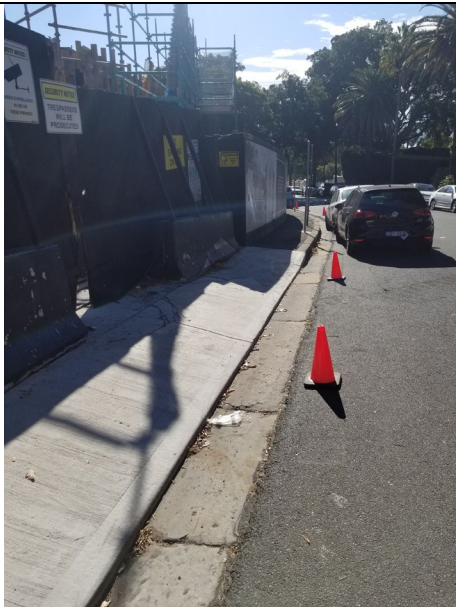
Z92, Z136, Z143, Z219, Z224	2/6/2021	
Description:		
Hoarding around the site boundary.		
Traffic control measures in place.		
Room for vehicles to be contained wholly within the site.

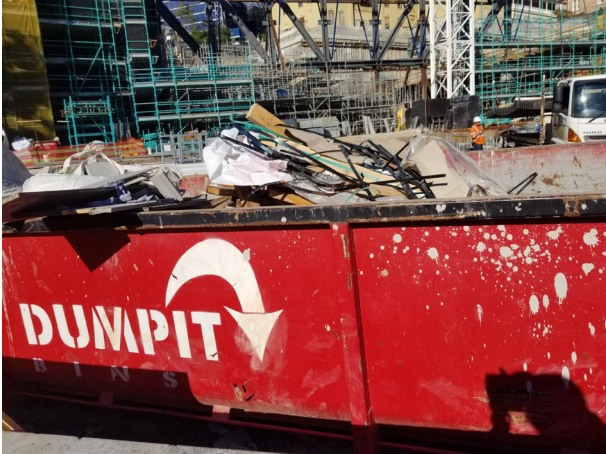
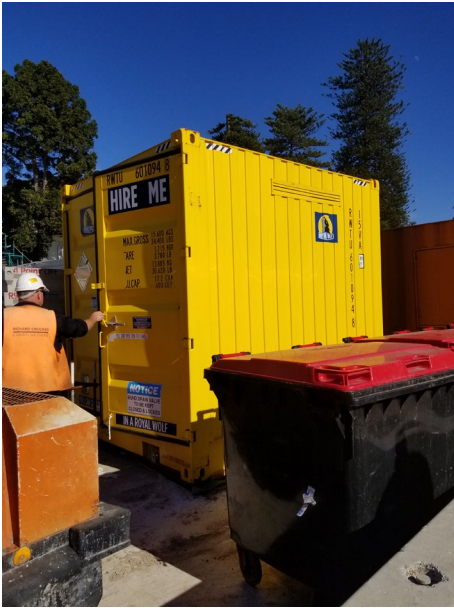
<div><div>Zoic Ref.: Z107, Z138, Z165, Z180, Z230</div><div>Date: 2/6/2021</div></div>	<div><div>

</div></div>
<div><div>Description:</div><div>Waste segregation and storage, stockpile construction.</div></div>

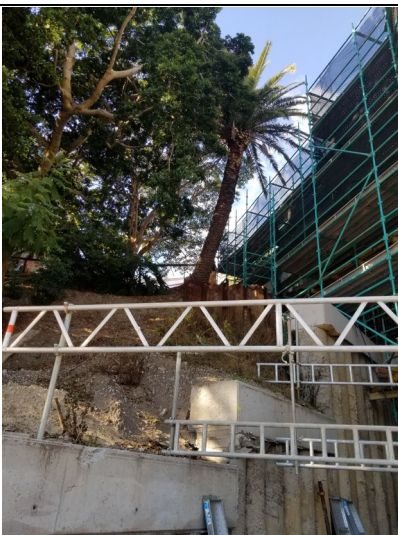
Z141	2/6/2021	
<p>Description:</p> <p>Tree protection zone barricades observed. Signage was observed posted around the TPZs.</p>

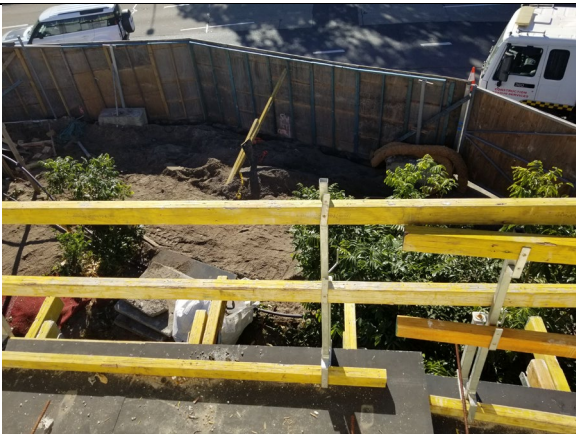
Z144, Z172, Z173, Z176, Z177, Z231	2/6/2021	
Description:		 
Mulching along northern boundary.		
Sausage bunds on kerbside inlets.

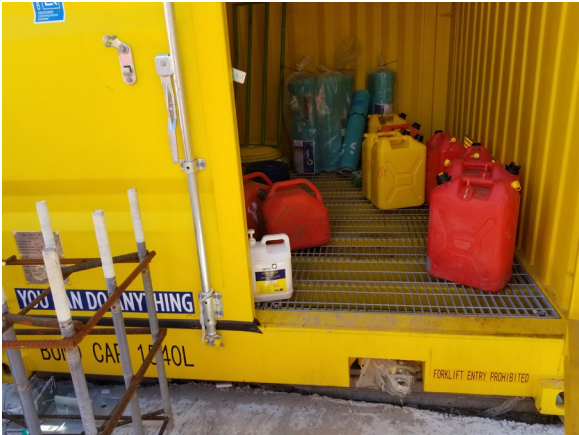
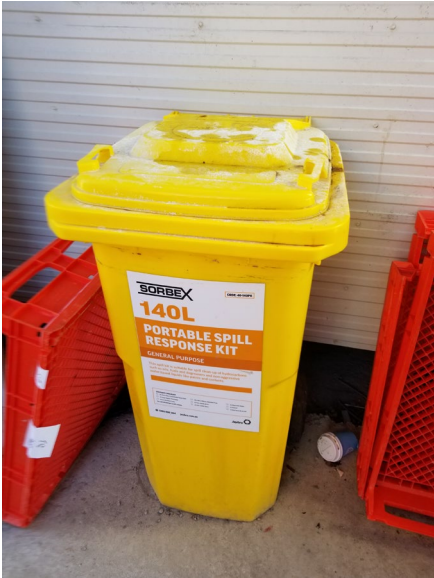
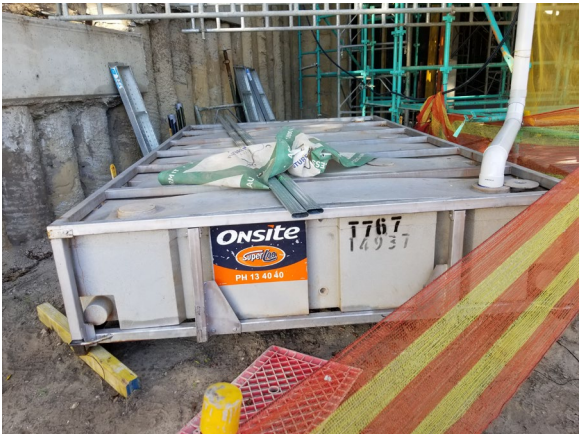
Chemical storage placed on bunding. Spill located adjacent to yellow container.

Waste water tank collection on-site for the structure amenities. The rest of the site is connected to sewer.
