Pre-Construction Dilapidation & Photographic Survey of RMS Infrastructure Rose Bay Avenue and New South Head Road

DATE	30/10/2019
TO	EPM Projects Pty Ltd
ATTN	Mr Michael Nasiry
PROJECT	Cranbrook School Stage 2 Project
APPLICANT	Cranbrook School
APPLICATION NO.	SSD 8812

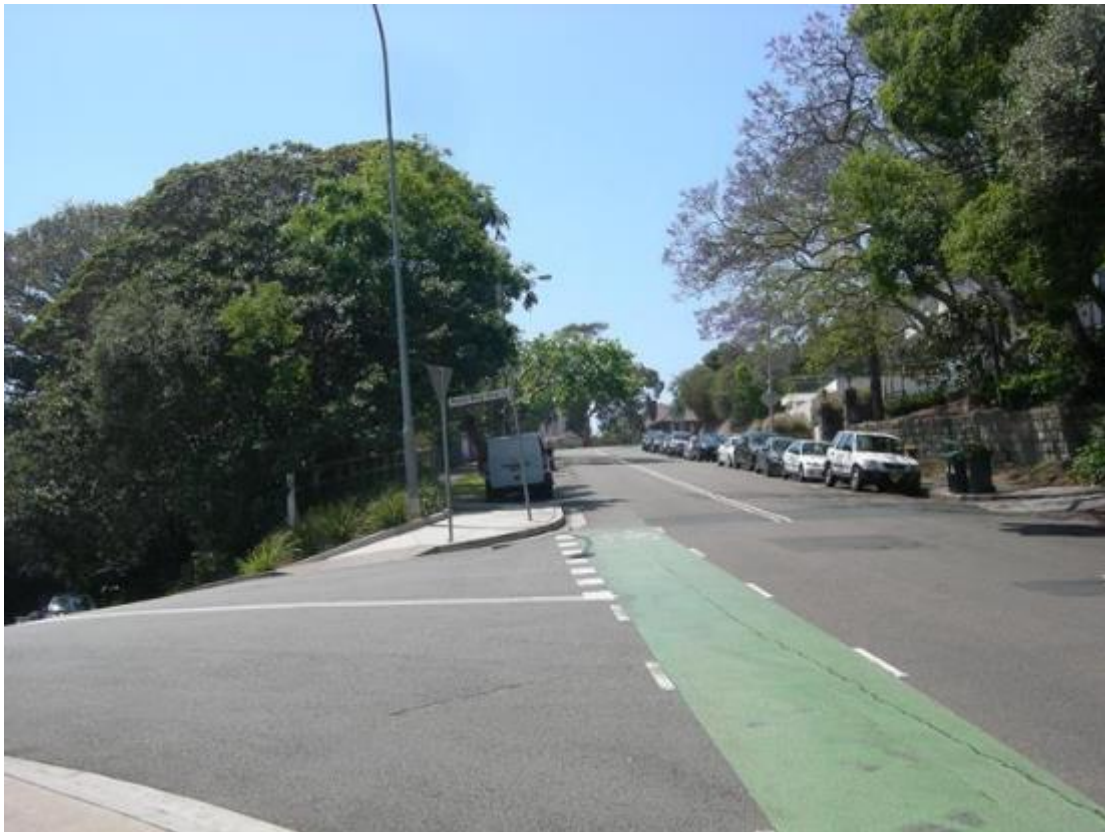
PHOTO 2

PHOTO NO	OBSERVATION
1 to 3	Indentations, cracks and localised pitting observed at Rose Bay Ave near Victoria Rd intersection
4	Crack at footpath at west of Rose Bay Ave near Victoria Rd intersection
5	Joints, indentations and tyre marks along north bound lane of Rose Bay Ave near Victoria Rd intersection
6	Eastern boundary fence of the school along Rose Bay Ave near Victoria Rd intersection
7	Cracks and holes at west footpath of Rose Bay Ave
8	Cracks and indentations along north bound lane of Rose Bay Ave
9	Wide cracks along west footpath of Rose Bay Ave
10 & 11	Joints, cracks and indentations along north bound lane of Rose Bay Ave
12 & 13	Broken kerb and wide cracks along west footpath of Rose Bay Ave. Also, school fence noted to be broken and out of plumb
14	Along north bound lane of Rose Bay Ave cracks, indentations and localised pitting observed
15 & 17	Broken and out of plumb timber fence at west footpath of Rose Bay Ave

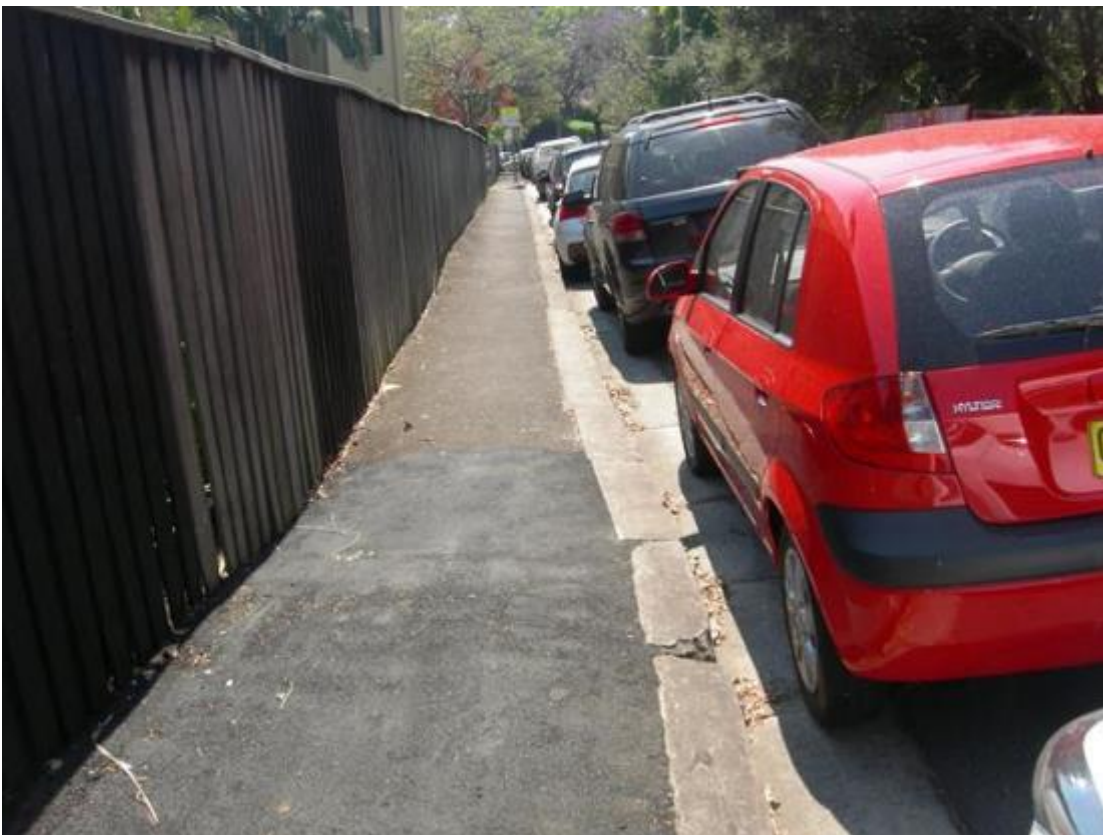
PHOTO 18

16	Localised pitting and cracks at parking lane at west of Rose Bay Ave
18	Cracks at footpath and broken kerb & gutter at west of Rose Bay Ave
19	Along north bound lane of Rose Bay Ave cracks, indentations and localised pitting observed

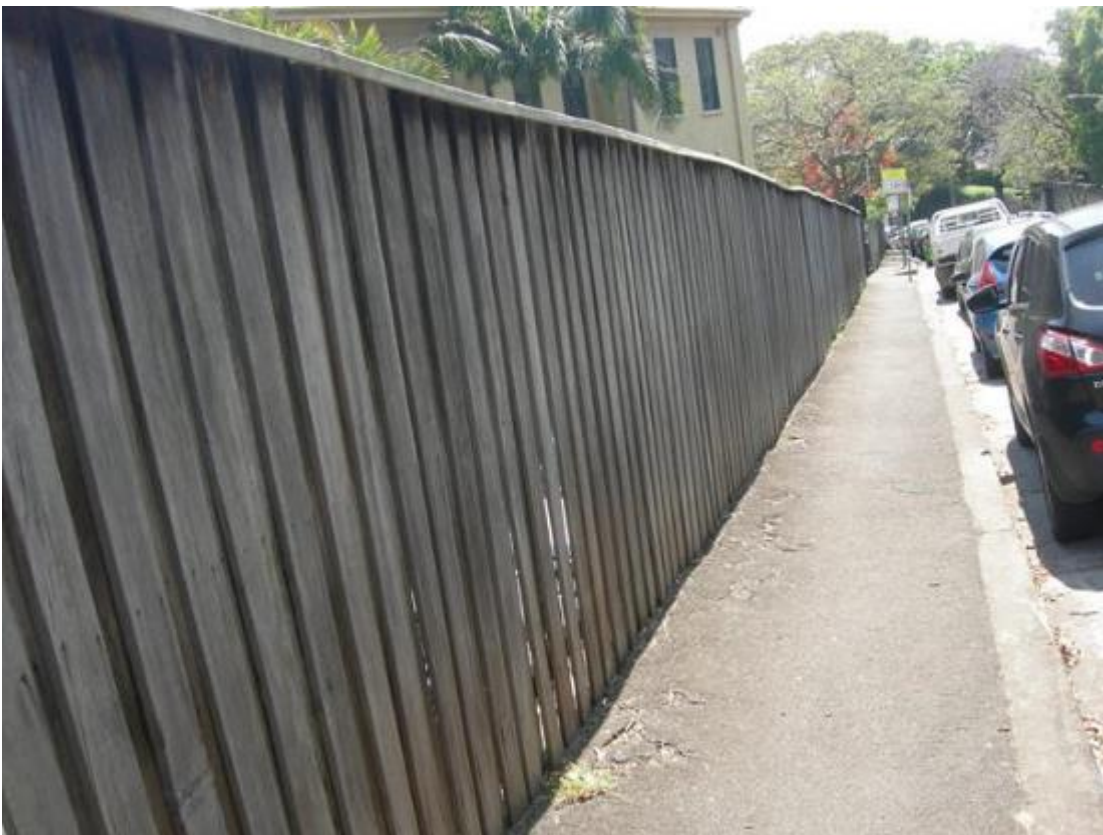
PHOTO 20

PHOTO NO	OBSERVATION
20	Wide cracks along west footpath of Rose Bay Ave
21 & 22	Along north bound lane of Rose Bay Ave cracks, indentations and localised pitting observed
23	Broken kerb and wide cracks along west footpath of Rose Bay Ave. Also, school fence noted to be out of plumb
24	Tyre marks, cracks, indentations and localised pitting along north bound lane of Rose Bay Ave
25 to 32	Cracks at footpath, broken kerb & gutter and out of plumb timber fence at west of Rose Bay Ave
33	Along north bound lane of Rose Bay Ave cracks, indentations and localised pitting observed
34 to 38	Cracks at footpath, broken kerb & gutter and broken & out of plumb timber fence at west of Rose Bay Ave
39	Along north bound lane of Rose Bay Ave cracks, indentations and localised pitting observed
40 to 47	Cracks at footpath, broken kerb & gutter and broken & out of plumb timber fence at west of Rose Bay Ave
48 to 50	Along north & south bound lanes of Rose Bay Ave cracks, indentations and localised pitting noted

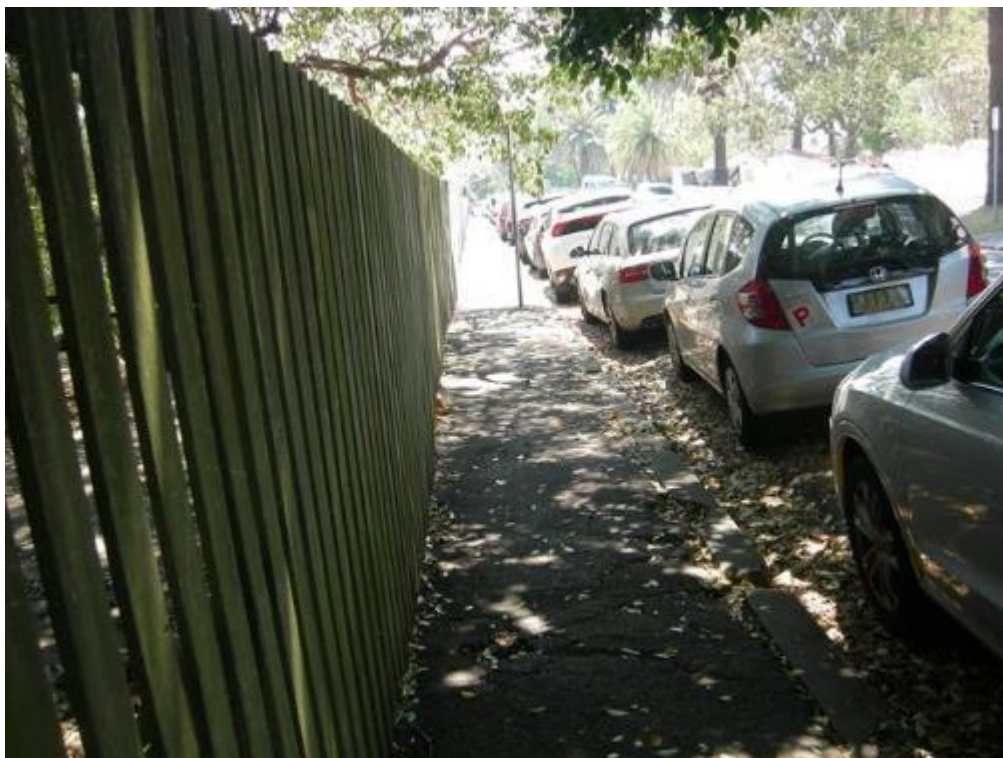
PHOTO 52

51 to 54	Cracks at footpath, broken kerb & gutter and broken & out of plumb timber fence at west of Rose Bay Ave
55	Along north bound lane of Rose Bay Ave cracks, indentations and localised pitting observed
56 to 59	Holes & Cracks at footpath and broken kerb & gutter at west of Rose Bay Ave
60 to 62	Along north & south bound lanes of Rose Bay Ave cracks, indentations and localised pitting noted
63 to 64	Wide Cracks at footpath and broken kerb & gutter at west of Rose Bay Ave
65 to 66	Uneven settlement, cracks, indentations and localised pitting noted along north & south bound lanes of Rose Bay Ave
67 to 72	Cracks at footpath, broken kerb & gutter and out of plumb timber fence at west of Rose Bay Ave
73 to 79	Along north & south bound lanes of Rose Bay Ave cracks, indentations and localised pitting noted near New South Head Rd intersection
80 to 82	Uneven settlement, wide cracks, broken kerb & gutter noted at west of Rose Bay Ave near New South Head Rd intersection

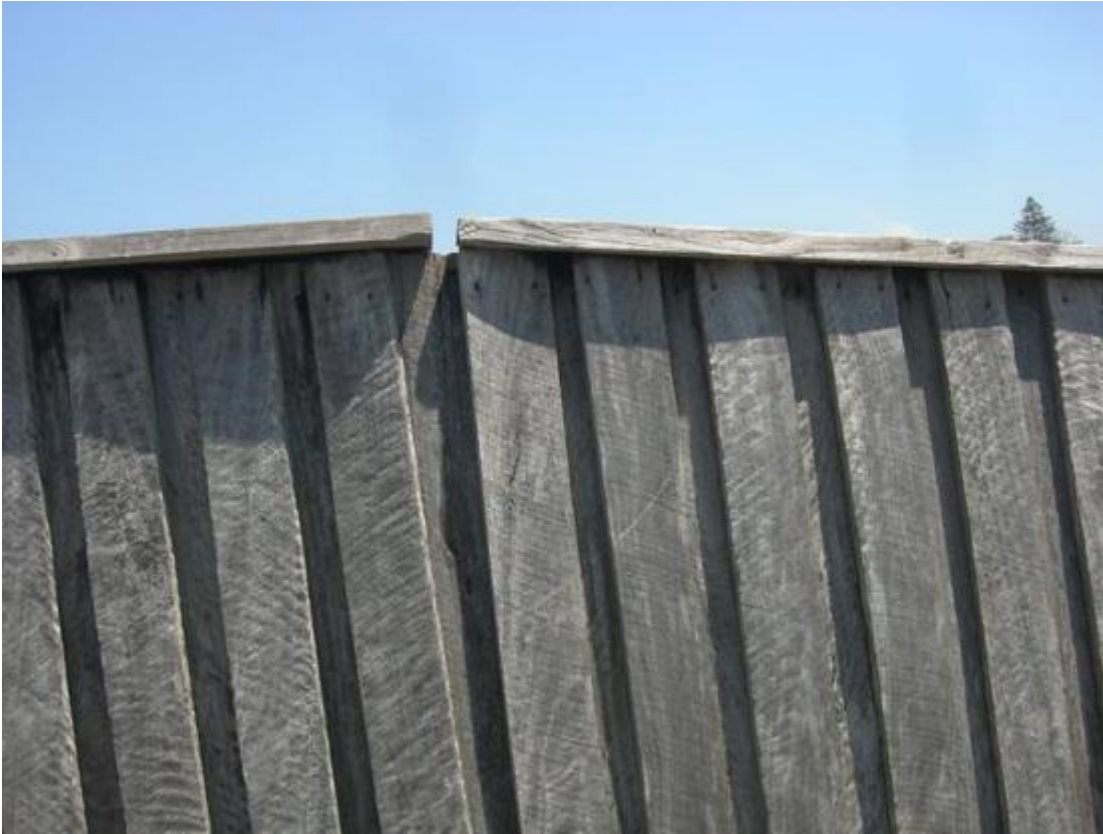
PHOTO 83

83 to 84	Broken and out of timber fence at west of Rose Bay Ave near New South Head Rd intersection
85 to 87	Cracked kerb & gutter and broken & out of plumb timber fence at west of Rose Bay Ave near New South Head Rd intersection. Also missing timber fence at bottom noted

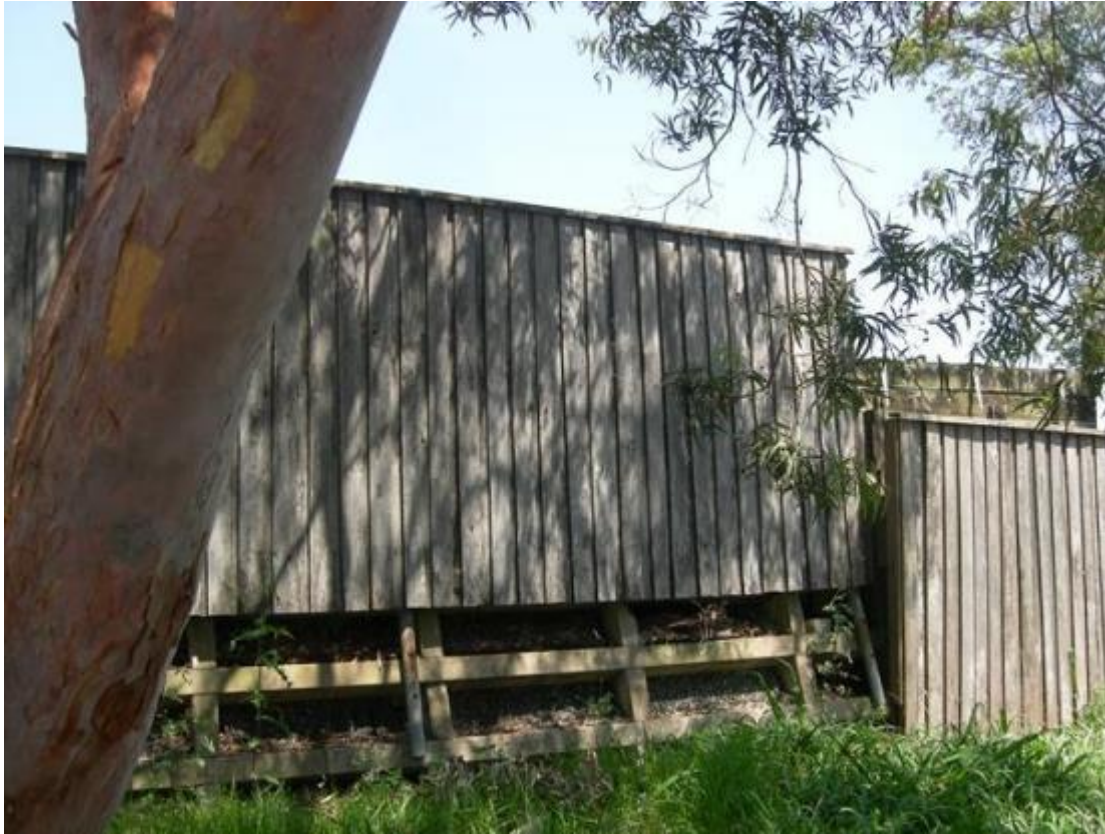
PHOTO 89

PHOTO NO	OBSERVATION
88	Along north bound lane of Rose Bay Ave cracks, indentations and localised pitting noted near New South Head Rd intersection
89	Missing timber fence at west of Rose Bay Ave near New South Head Rd intersection
90 to 93	Along north & south bound lanes of Rose Bay Ave cracks, indentations and localised pitting noted near New South Head Rd intersection
94 to 96	At Rose Bay Ave near New South Head Rd intersection broken kerb at west footpath and cracks, indentations and pitting along north bound lane noted
97 to 98	Telstra Pit and Electrical Pillar at west of Rose Bay Ave near New South Head Rd intersection
99 to 103	At Rose Bay Ave near New South Head Rd intersection broken kerb at west footpath and cracks, indentations and pitting along north bound lane noted
104 to 105	Looking north, joints, uneven surface, indentations and cracks at New South Head Rd near intersection of Rose Bay Ave

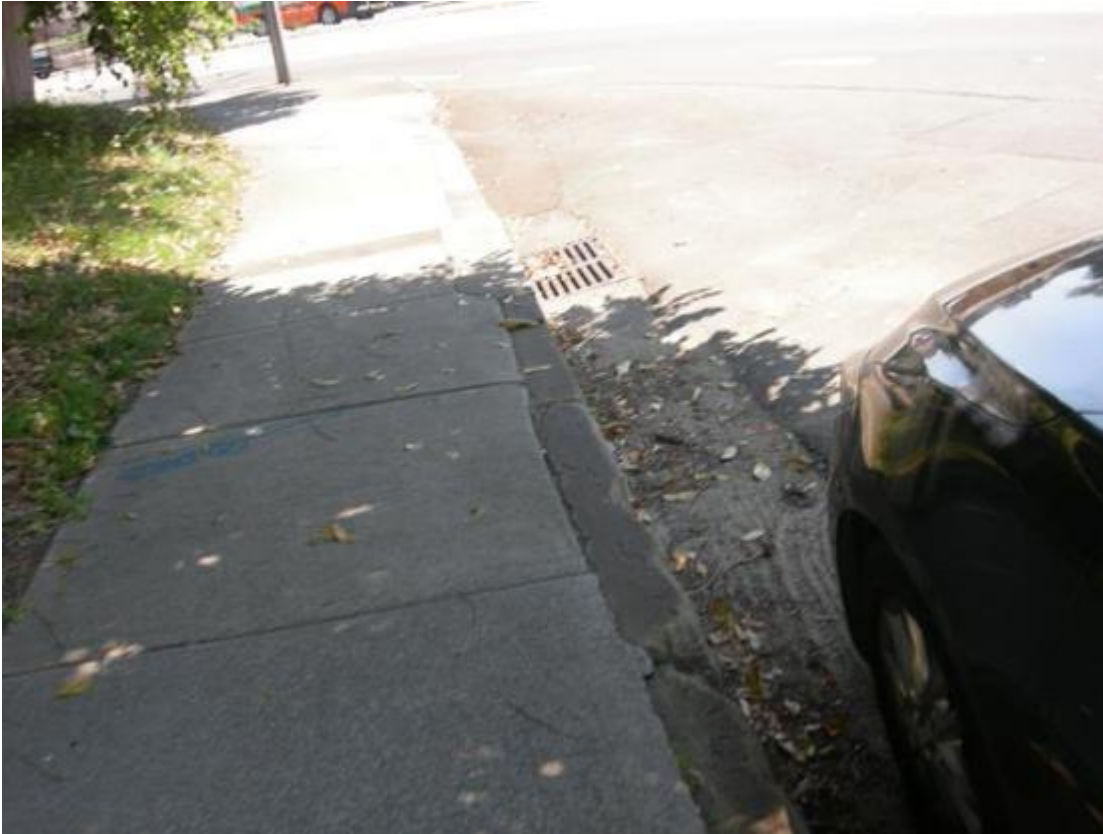
PHOTO 107

106	Man-hole at footpath near intersection of New South Head Rd & Rose Bay Ave
107 to 111	At Rose Bay Ave near New South Head Rd intersection broken kerb at west footpath and cracks, indentations and pitting along north bound lane noted
112 to 114	Along west bound lane of New South Head Rd near Rose Bay Ave intersection cracks indentations and localised pitting observed. Also, cracked kerb & gutter noted.
115	Broken timber fence at south of New South Head Rd
116 to 120	Along west bound lane of New South Head Rd intersection cracks indentations and localised pitting observed. Also, cracked kerb & gutter noted.
121 to 125	Light poles, service pits, footpath and kerb & gutter along south footpath of New South Head Rd
126 to 129	Looking west at New South Head Rd, cracks at footpath and kerb & gutter noted. Along roadway repair patches, cracks, joints, indentations and localised pitting observed along west bound lane

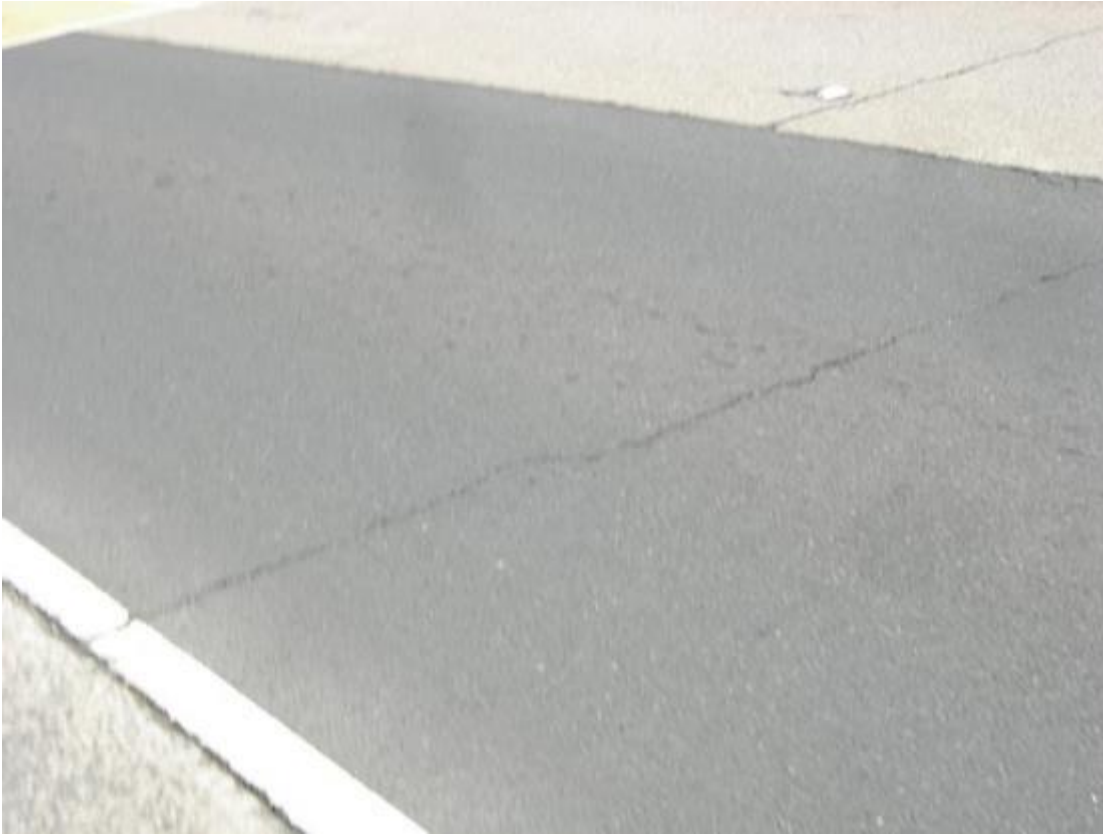
PHOTO 131

130	School Zone sign board at New South Head Rd
131	Cracked roadway along west bound lane, New South Head Rd
132	Broken timber fence at south of New South Head Rd
133 to 134	Uneven footpath and broken timber fence at south of New South Rd
135	Looking north cracked roadway, repair patches and indentations along west bound lane of New South Head Rd
136	Broken kerb & gutter at south of New South Head Rd
137	Looking north uneven roadway, repair patches and indentations along west bound lane of New South Head Rd
138	Electrical Pillar at southern footpath of New South Head Rd
139	Crack at west bound lane of New South Head Rd
140 to 142	Uneven and cracked driveway

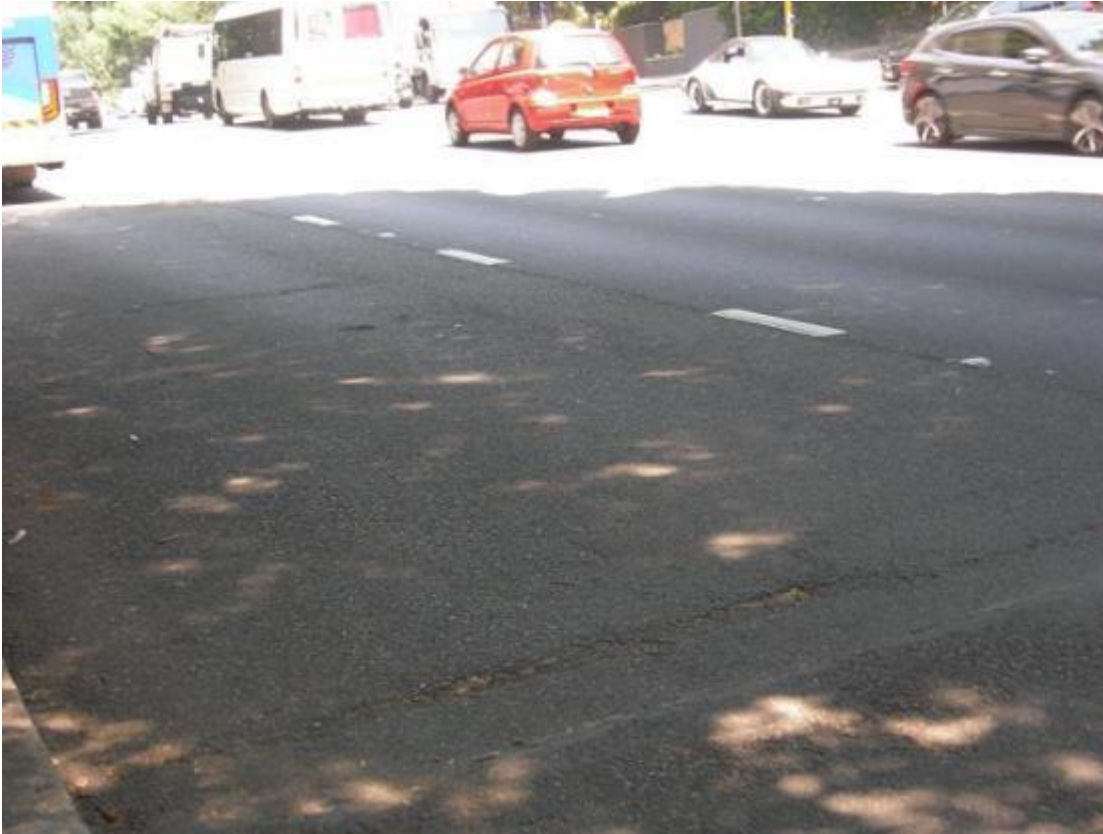
PHOTO 143

PHOTO NO	OBSERVATION
143 to 144	Cracks and indentations at west bound lane of New South Head Rd
145	Uneven kerb at south near bus shelter, New South Head Rd
146	General view of footpath at south near bus shelter at New South Head Rd
147	Cracks, localised pitting and indentations at west bound lane of New South Head Rd
148	Metal fence along south of New South Head Rd
149	Cracked footpath near bus shelter, New South Head Rd
150	View of footpath at backside of bus shelter
151 to 152	Broken concrete pad and cracks at bus shelter, New South Head Rd
153 to 154	Timber roof framing at bus shelter, New South Head Rd
155	Timber Wall framing at bus shelter, New South Head Rd
156	Looking north cracks, indentations and repair patches at west bound lane in front of bus shelter, New South Head Rd
157 to 159	Cracked and uneven footpath & driveway near bus shelter, New South Head Rd
160	General view of tiled roof at bus shelter, New South Head Rd
