Report on Additional Geotechnical Investigation

Cranbrook School ECI Victoria Road, Bellevue Hill

> Prepared for Cranbrook School

Project 84944.02 October 2018

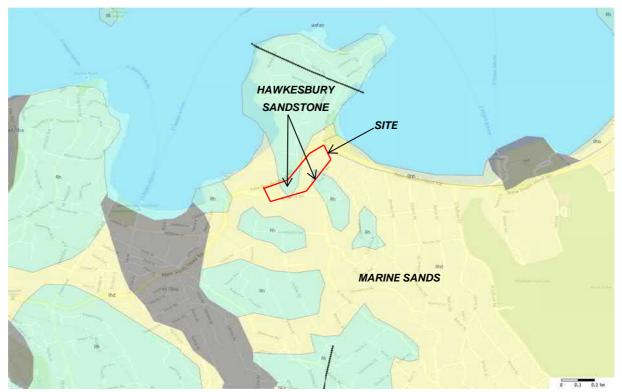
Figure 1: Extract from geological map

The Sydney 1:100 000 Geological Series Sheet shows that the site is underlain by Hawkesbury Sandstone with some overlying quaternary-aged marine sands with podsols. An extract of the geological map is shown in Figure 1.

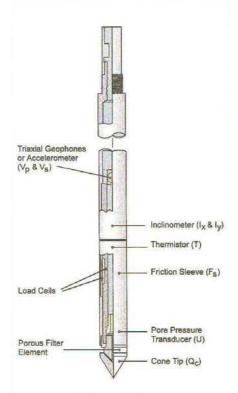
Figure 1: Cone Diagram

The soil parameters measured depend on the type of cone being used, however they always include the following basic measurements

•	Cone tip resistance	$q_c$
•	Sleeve friction	$f_s$
•	Inclination (from vertical)	i
•	Depth below ground	Z

The inclinometer in the cone enables the verticality of the test to be confirmed and, if required, the vertical depth can be corrected.

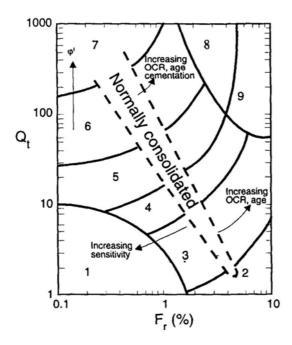
Figure 3: Soil Classification Chart

The CPT parameters can be used to infer the Soil Behaviour Type (SBT), based on normalised values of cone resistance (Qt) and friction ratio (Fr). These are used in conjunction with soil classification charts, such as the one below (after Robertson 1990)

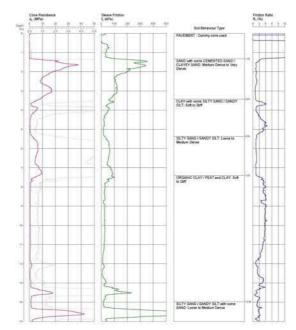
Figure 4: Sample Cone Plot

Other applications of CPT include ground improvement monitoring (testing before and after works), salinity and contaminant plume mapping (conductivity cone), preloading studies and verification of strength gain.

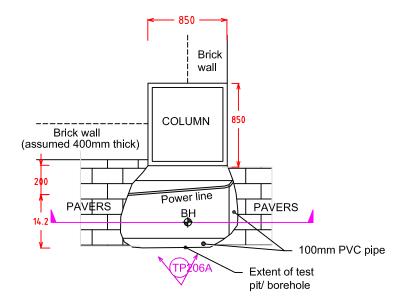
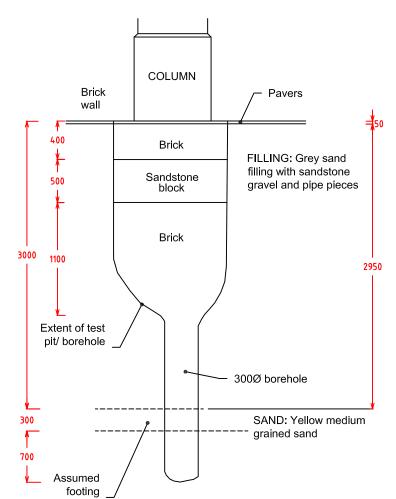
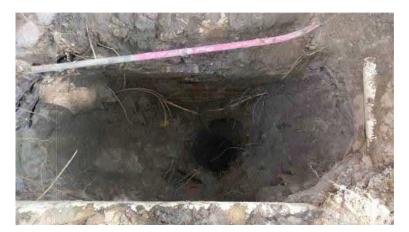
#### **TP206A PLAN**

**TP206A ELEVATION**

**TP206A**

Two test pits (TP206 and TP207) were excavated adjacent to the Perkins Building to assess the footing and foundation conditions. These pits were initially excavated to depths of 1.5 m and 1.4 m using a small excavator with bucket attachment. The base of the footings could not be located within these pits and therefore additional pits were excavated at the same locations using a combination of a bucket attachment and an auger to achieve a greater investigation depth of 3 m.

Sketches showing the conditions encountered in the test pits, including photographs, are shown in Drawings G6 to G14 in Appendix B.

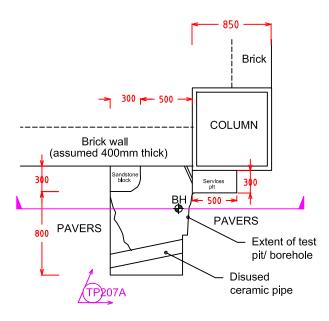
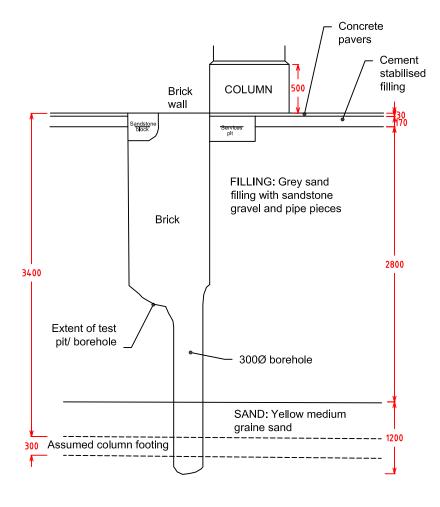
#### **TP207A PLAN**

**TP207A**

**TP207A ELEVATION**

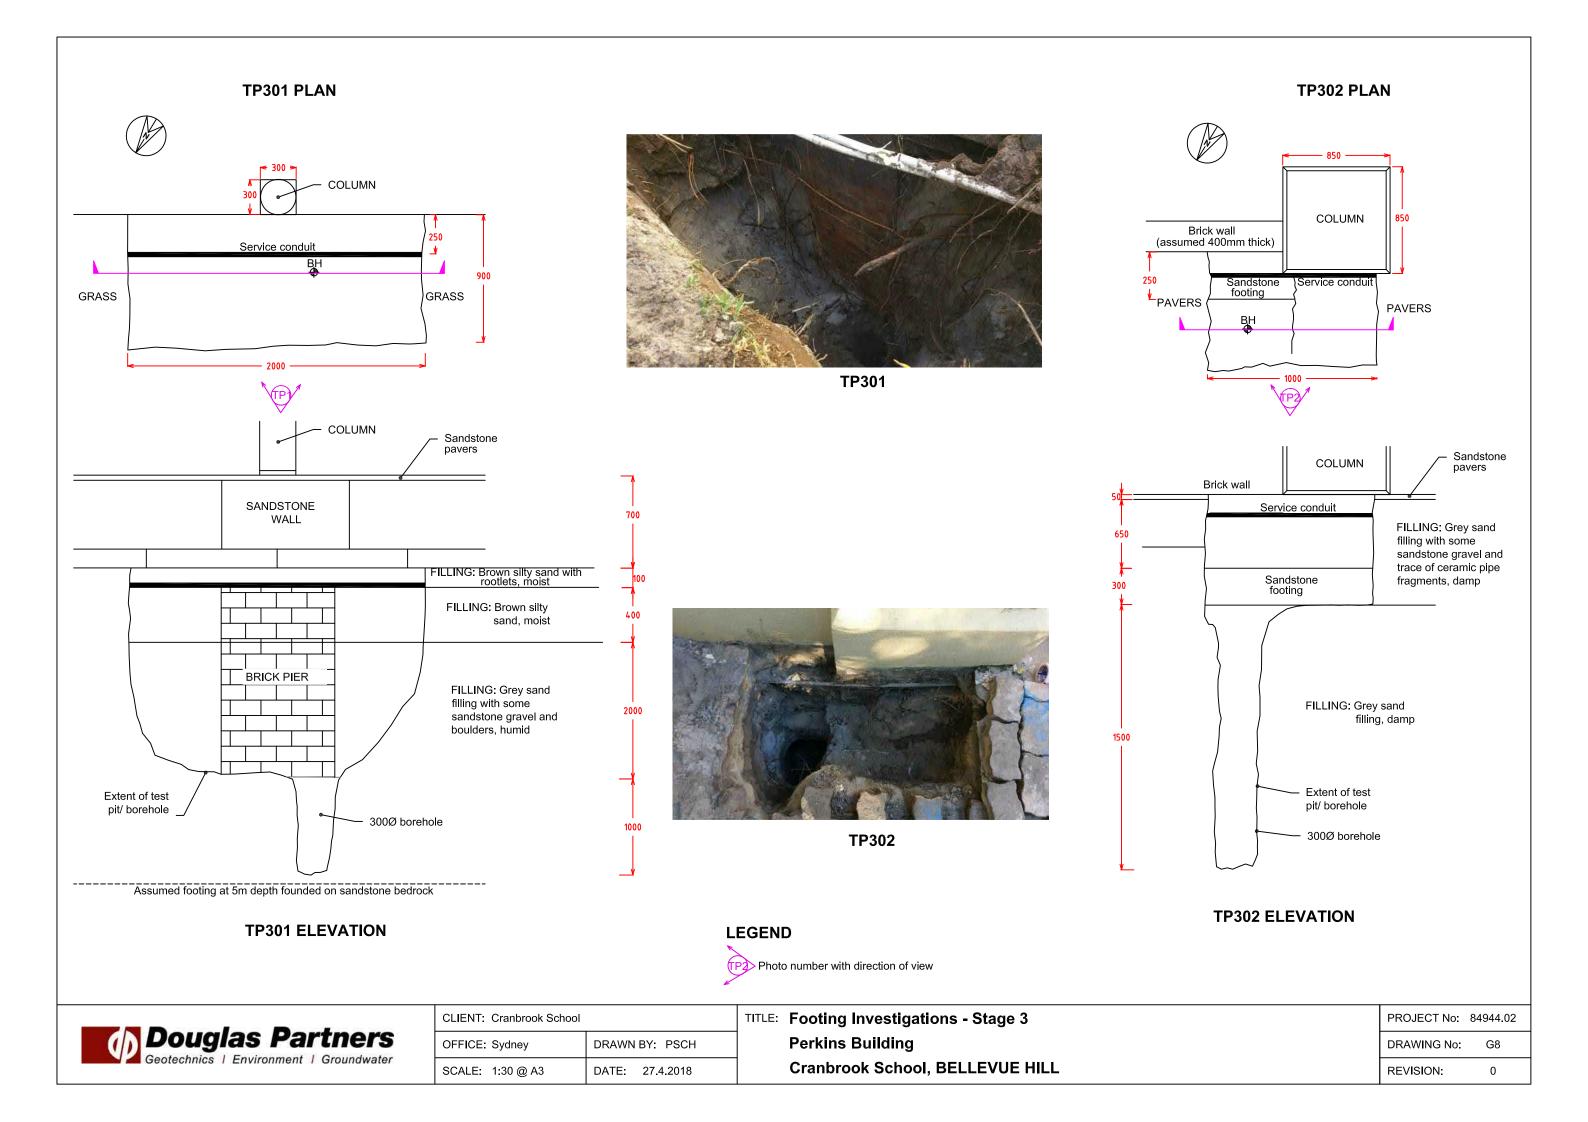
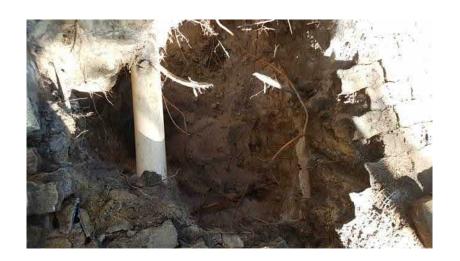
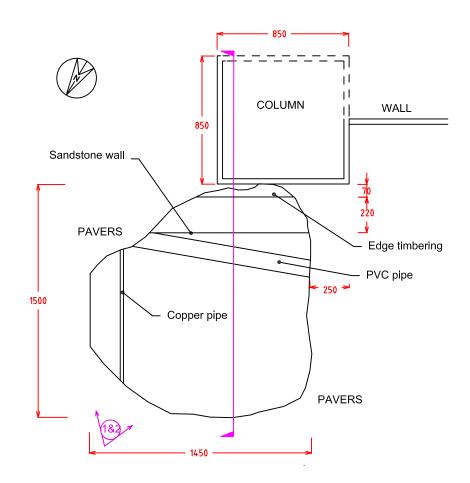
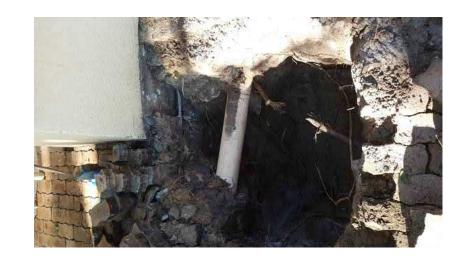
PROJECT No:	84944.02
DRAWING No:	G9
REVISION:	0

# **TP303 ELEVATION** Ground level COLUMN **PAVERS** FILLING: dark brown silty sand (fine to medium grained) with roots and bricks FILLING: pale grey fine PVC grained filling FILLING: brown slightly silty sand (medium grained) filling with concrete, slate, terracota and brick fragments <del>|<</del> 220 -Sandstone block

#### **TP303 PLAN**

The May 2018 field work included the excavation of five test pits (TP301 to TP305) adjacent to the Perkins Building and Cranbrook House to assess the footing and foundation conditions. These pits were excavated to depths of between 0.8 m and 3.5 m using a small excavator with bucket attachment. Six dynamic penetrometer tests (DPTs) were also undertaken between Perkins Building and the oval.

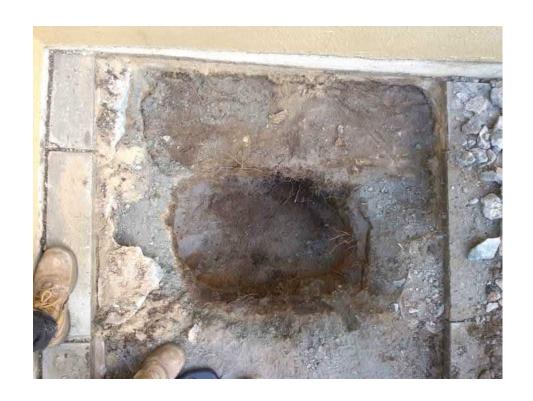
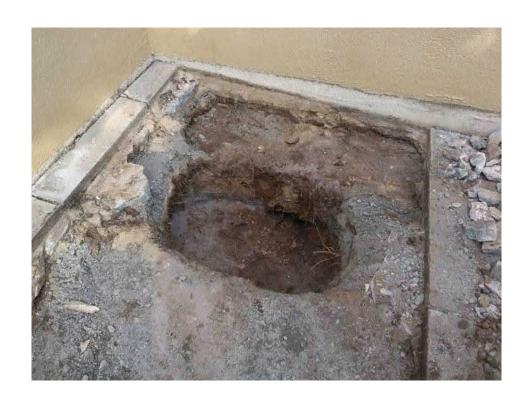
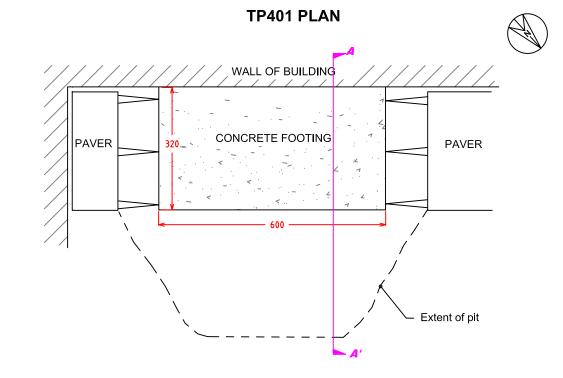
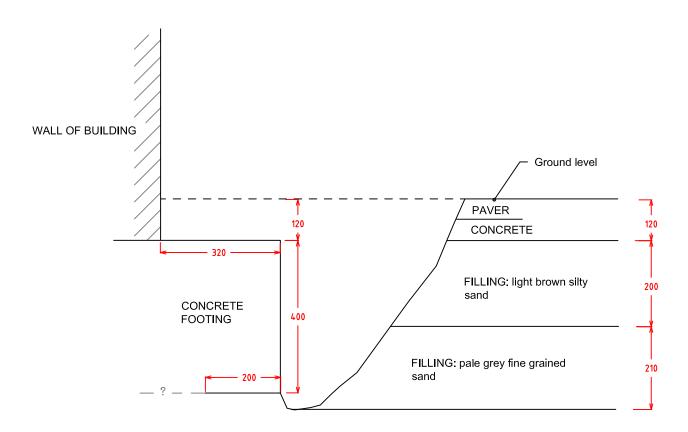
## TP401 Section A-A'

DPT rod inserted at the base of the footing at angle of about 45°. It was inserted to a depth of 1.9m and no footing or hard surface was encountered.

The July 2018 field work included the excavation of an additional two test pits (TP401 and TP402) adjacent to the eastern end of the Perkins Building to assess the footing and foundation conditions. These pits were excavated to depths of 0.5 m and 1.0 m using hand tools. Probing was undertaken below the apparent base of the footings using a steel rod, and a DPT was also undertaken in the base of each pit.

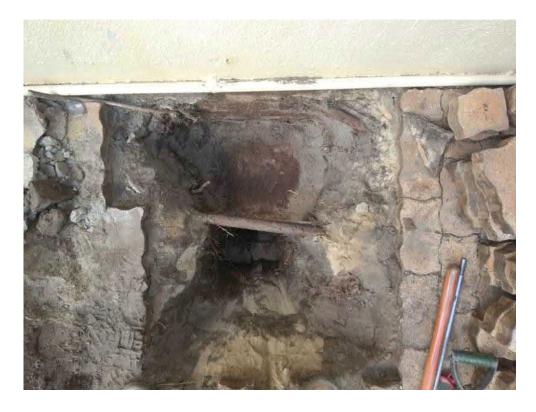
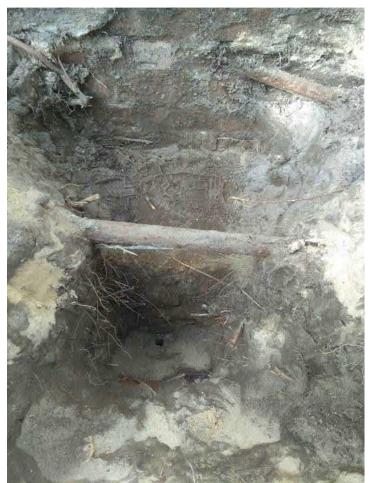
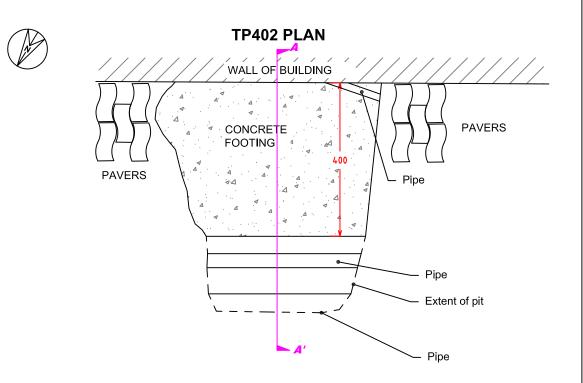
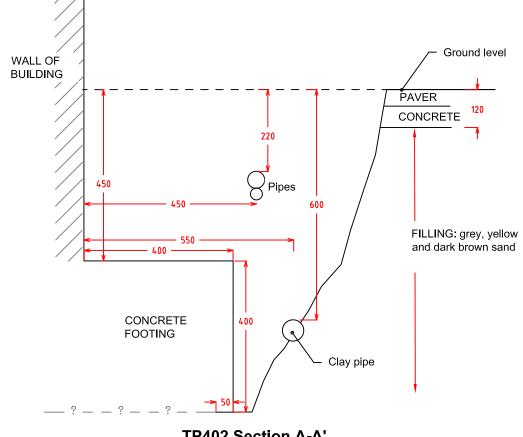
TP402 Section A-A'

DPT rod inserted at the base of the footing at angle of about 60°. It was inserted to a depth of 1.9m and no footing or hard surface was encountered.

TITLE: Footing Investigations - Stage 4 Perkins Building Cranbrook School, BELLEVUE HILL PROJECT No: 84944.02 DRAWING No: G13 REVISION: 0

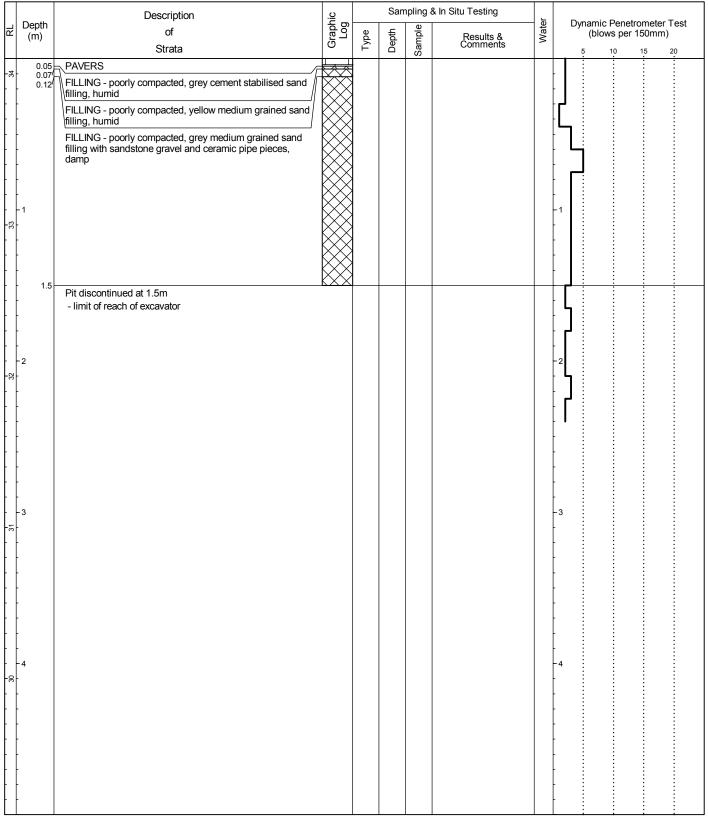
**PIT No: 206**

RIG: 1.8t excavator - 300mm bucket to 1.5m LOGGED: JN **SURVEY DATUM: MGA94**

WATER OBSERVATIONS: No free groundwater observed

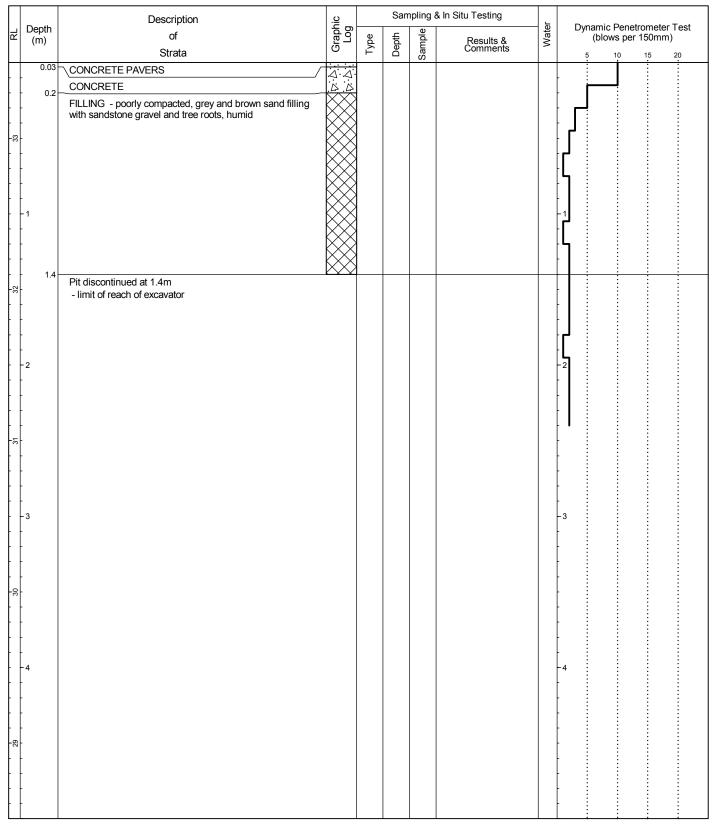
**EASTING**: 338336 **NORTHING**: 6250644 **PIT No: 207**

RIG: 1.8t excavator - 300mm bucket to 1.4m LOGGED: JN **SURVEY DATUM: MGA94**

WATER OBSERVATIONS: No free groundwater observed

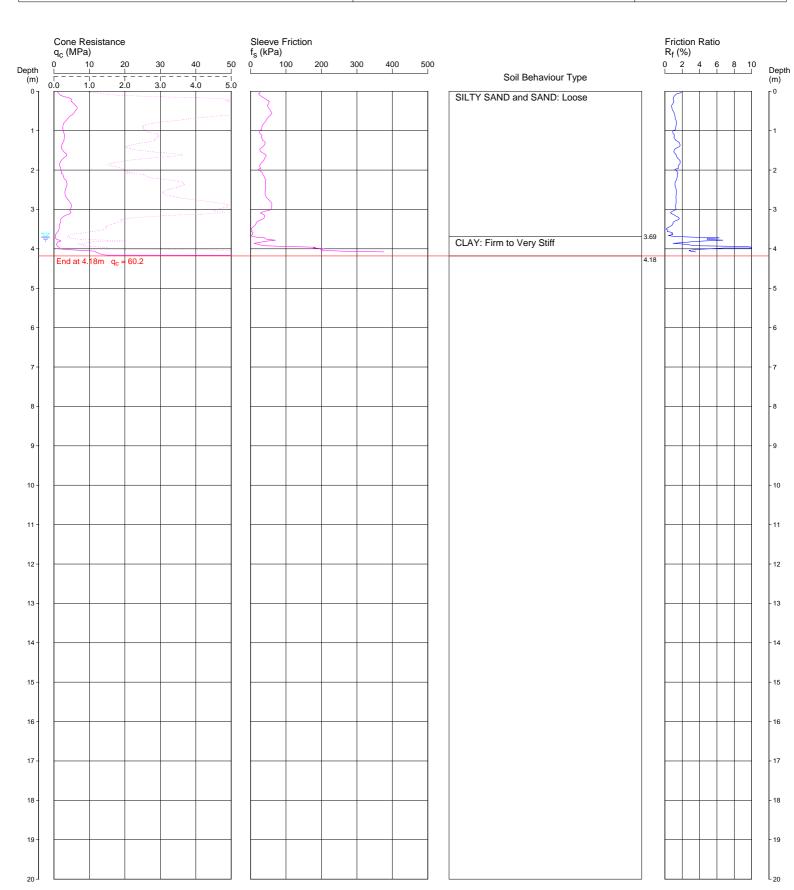
CPT1 Page 1 of 1

**REMARKS:** HOLE DISCONTINUED DUE TO CONE TIP REFUSAL; GROUNDWATER OBSERVED AT 3.7 m DEPTH AFTER WITHDRAWAL OF RODS.

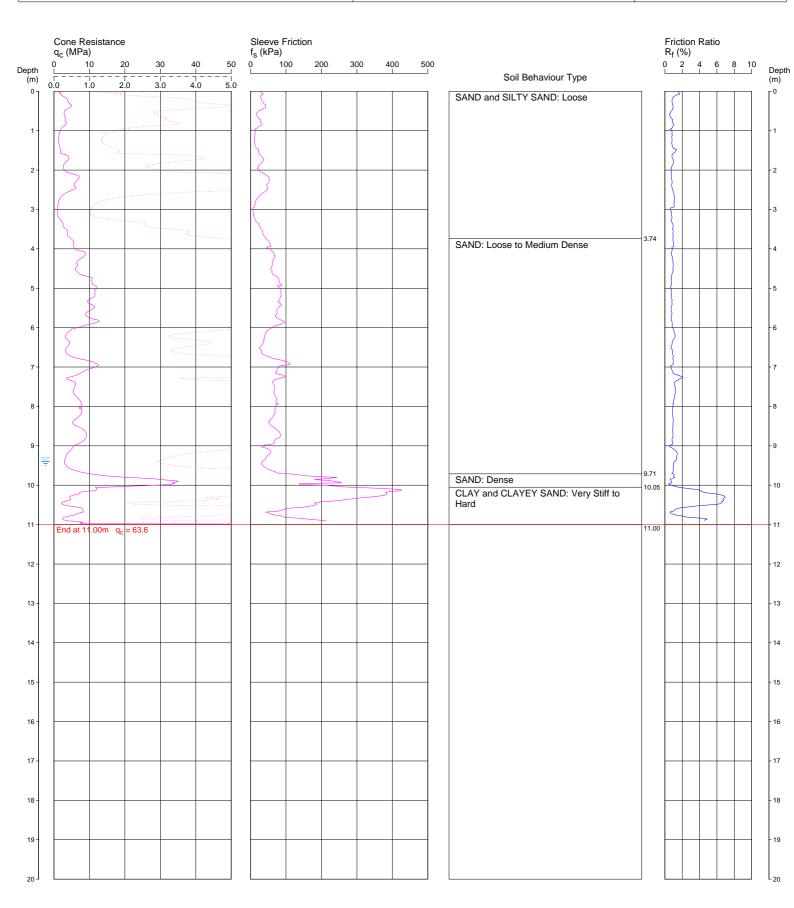
**REMARKS:** HOLE DISCONTINUED DUE TO CONE TIP REFUSAL; GROUNDWATER OBSERVED AT 9.4 m DEPTH AFTER WITHDRAWAL OF RODS.

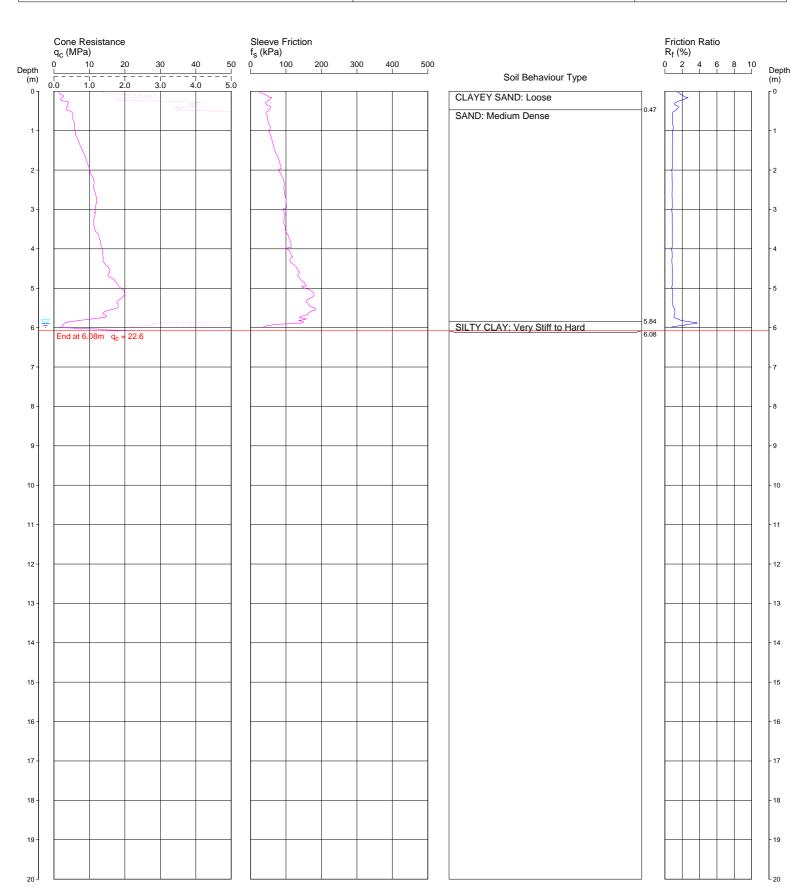
CPT3 Page 1 of 1

**REMARKS:** HOLE DISCONTINUED DUE TO BENDING; GROUNDWATER OBSERVED AT 5.9 m DEPTH AFTER WITHDRAWAL OF RODS.

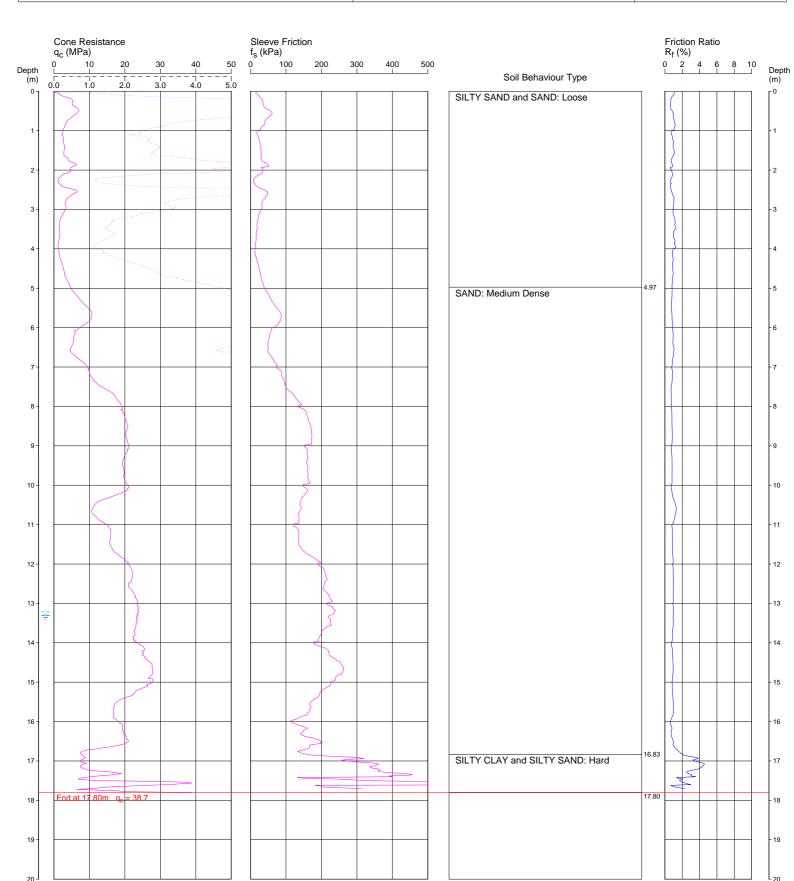
REMARKS: HOLE DISCONTINUED DUE TO CONE TIP REFUSAL; HOLE COLLAPSE AT 13.3 m AFTER WITHDRAWAL OF RODS.

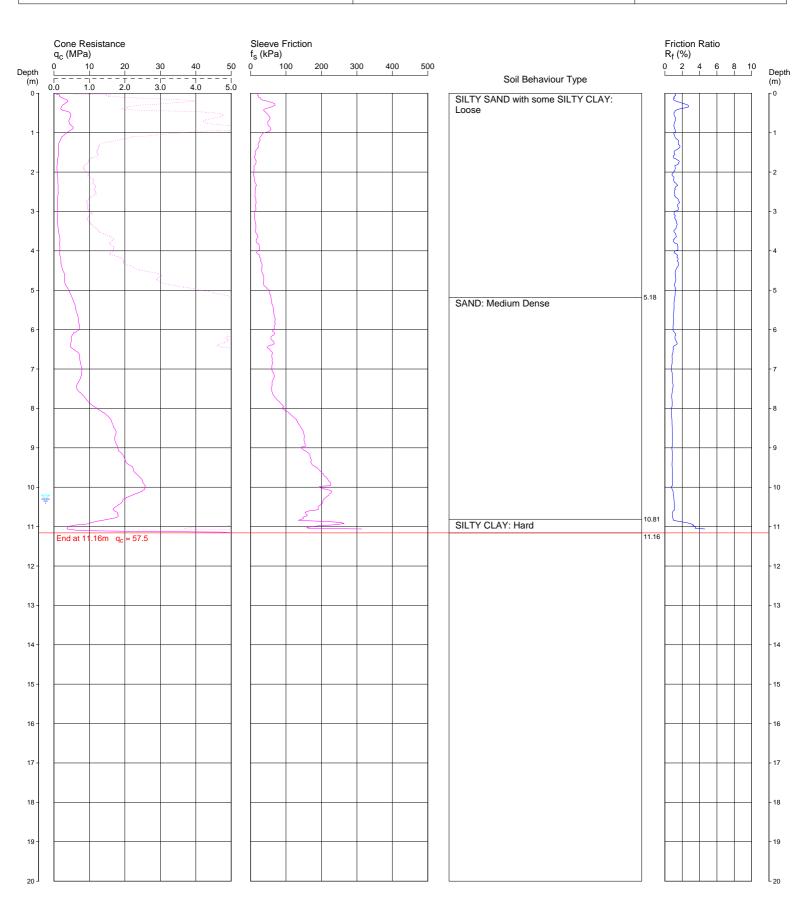
CPT5 Page 1 of 1

REMARKS: HOLE DISCONTINUED DUE TO CONE TIP REFUSAL; HOLE COLLAPSE AT 10.3 m DEPTH AFTER WITHDRAWAL OF RODS.

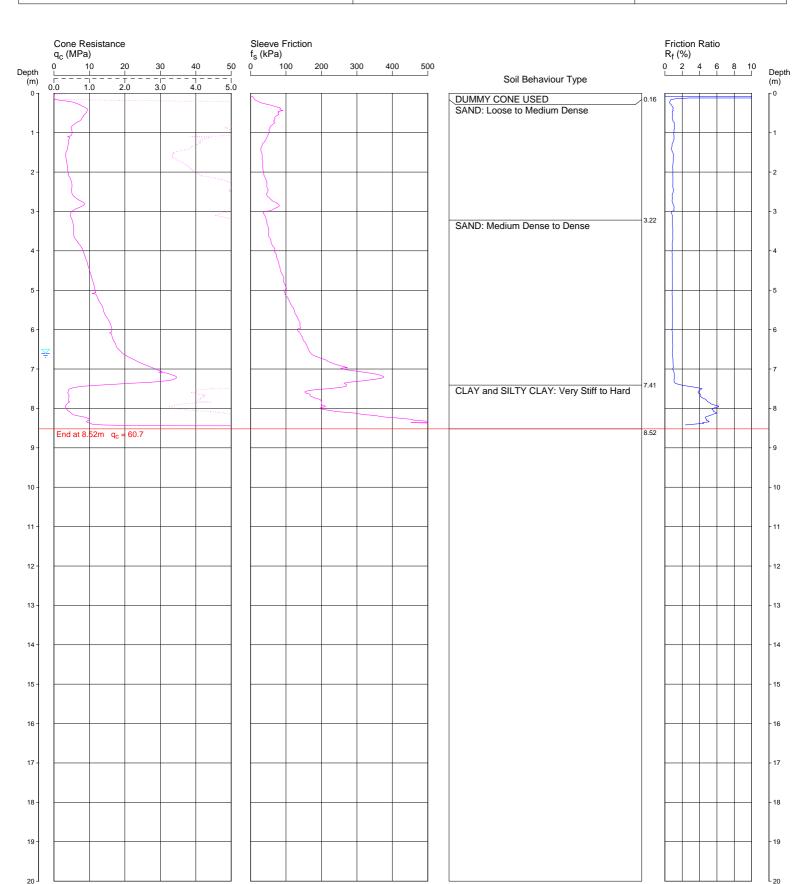
CPT6

REMARKS: DUMMY CONE USED FROM 0.0 TO 0.2 m DEPTH TO PENETRATE CONCRETE SLAB; HOLE DISCONTINUED DUE TO CONE TIP REFUSAL; HOLE COLLAPSE AT 6.6 m DEPTH AFTER WITHDRAWAL OF RODS.

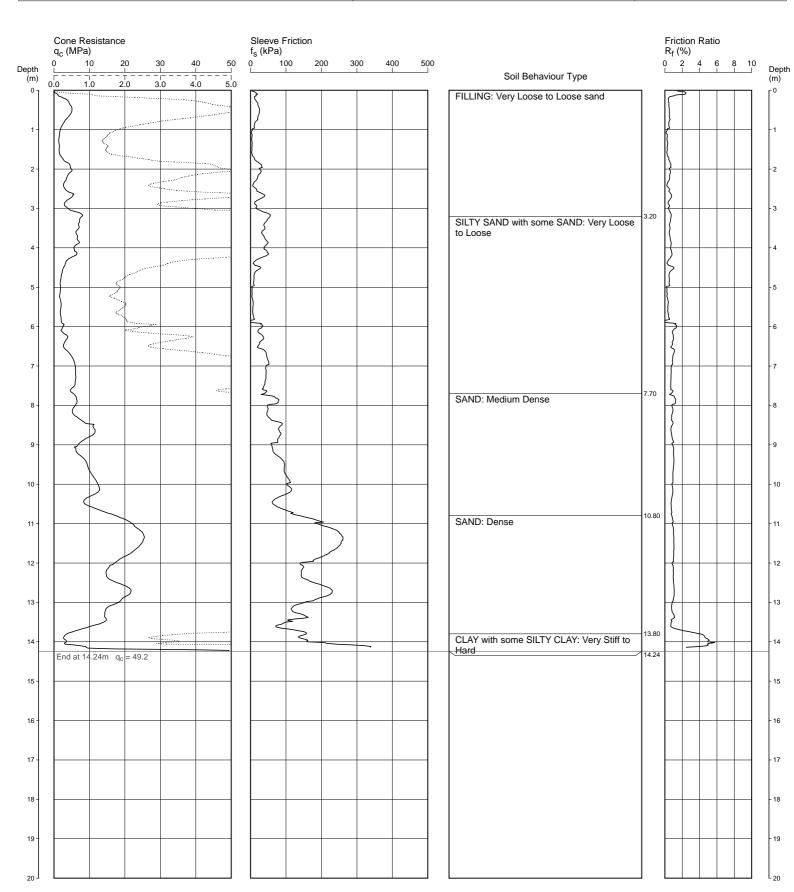
REMARKS: TEST DISCONTINUED DUE TO CONE TIP REFUSUAL;
GROUNDWATER WAS NOT OBSERVED DUE TO HOLE COLLAPSE AT 9.0 m DEPTH AFTER WITHDRAWAL OF RODS

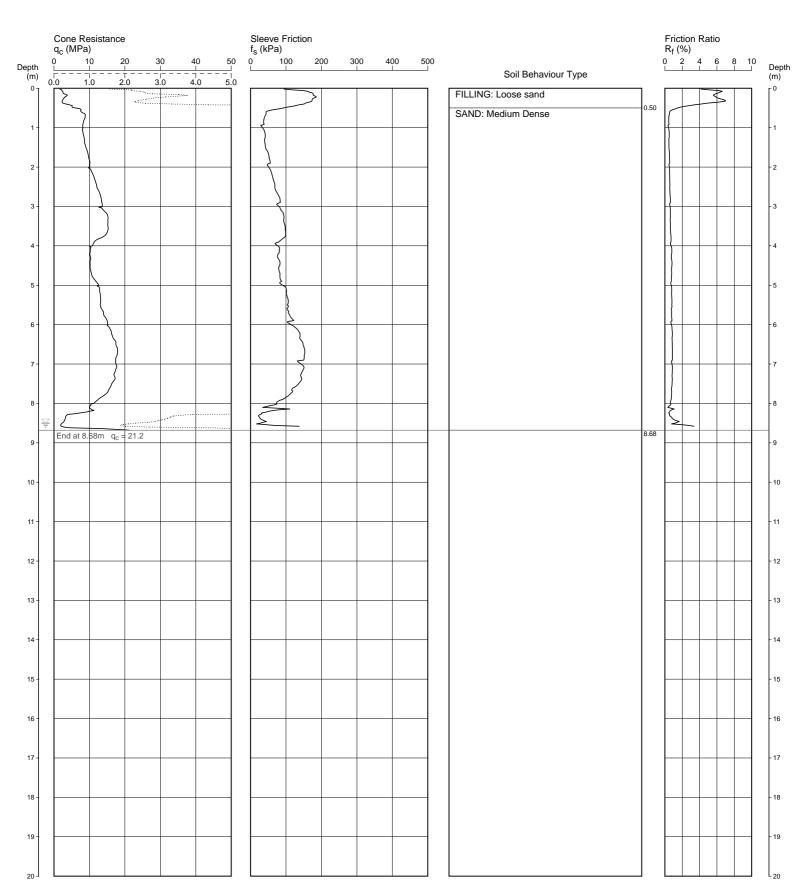
**REMARKS:** TEST DISCONTINUED DUE TO EXCESSIVE BENDING ON ROCK GROUNDWATER WAS OBSERVED AT 8.5 m DEPTH AFTER WITHDRAWAL OF RODS

Water depth after test: 8.50m depth (assumed)

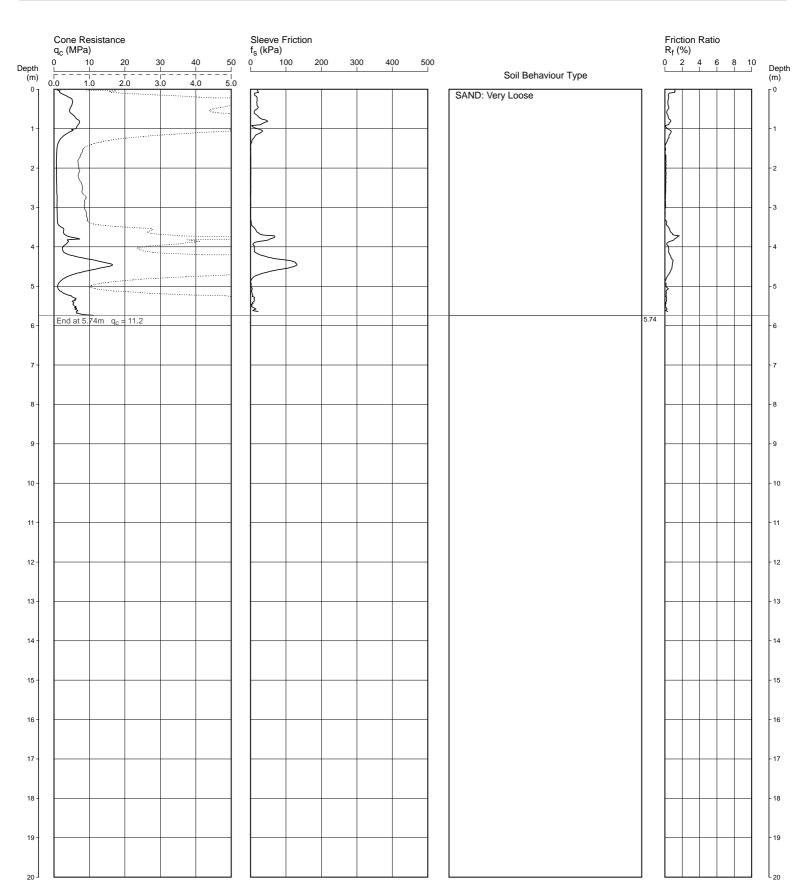
**CPT 104**

REMARKS: TEST DISCONTINUED DUE TO EXCESSIVE BENDING IN POSSIBLE ROCK NO GROUNDWATER WAS OBSERVED DUE TO HOLE COLLAPSE AT 4.2 m DEPTH AFTER WITHDRAWAL OF RODS

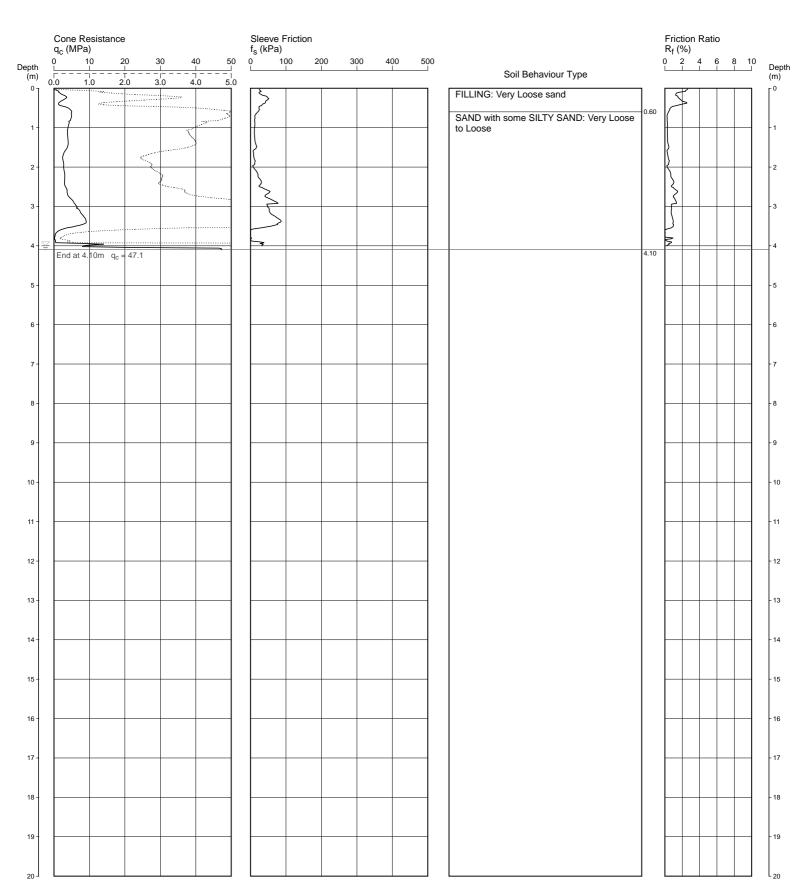
**REMARKS:** TEST DISCONTINUED DUE TO CONE TIP REFUSUAL; GROUNDWATER WAS OBSERVED AT 4.0 m DEPTH AFTER WITHDRAWAL OF RODS

Water depth after test: 4.00m depth (assumed)

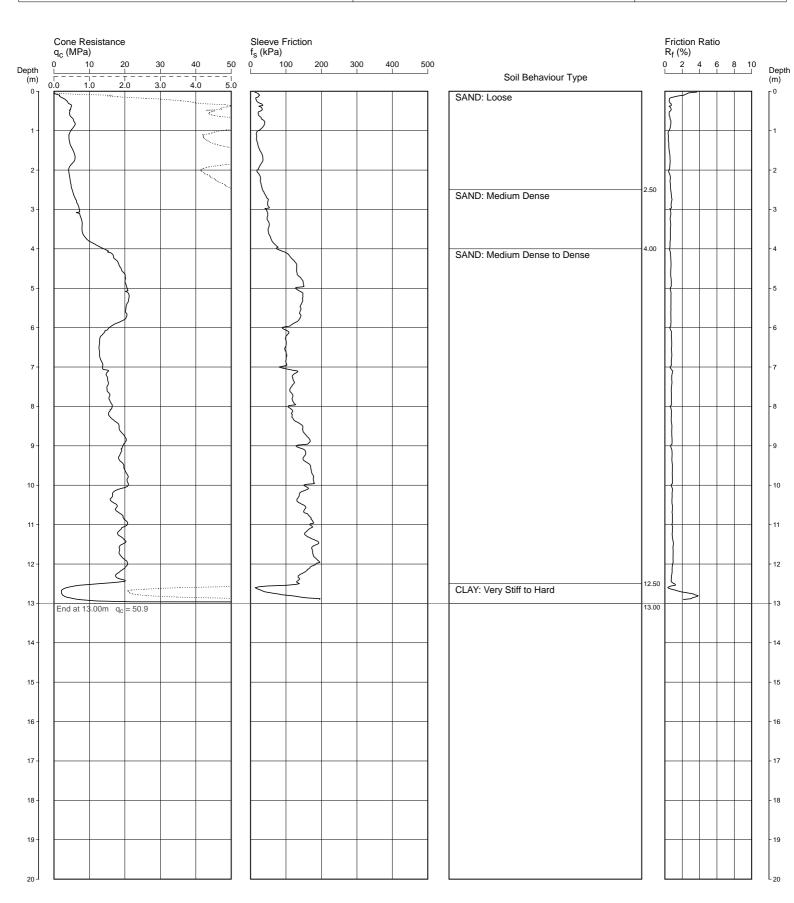
REMARKS: TEST DISCONTINUED DUE TO CONE TIP REFUSAL; NO GROUNDWATER WAS OBSERVED AFTER WITHDRAWAL OF RODS

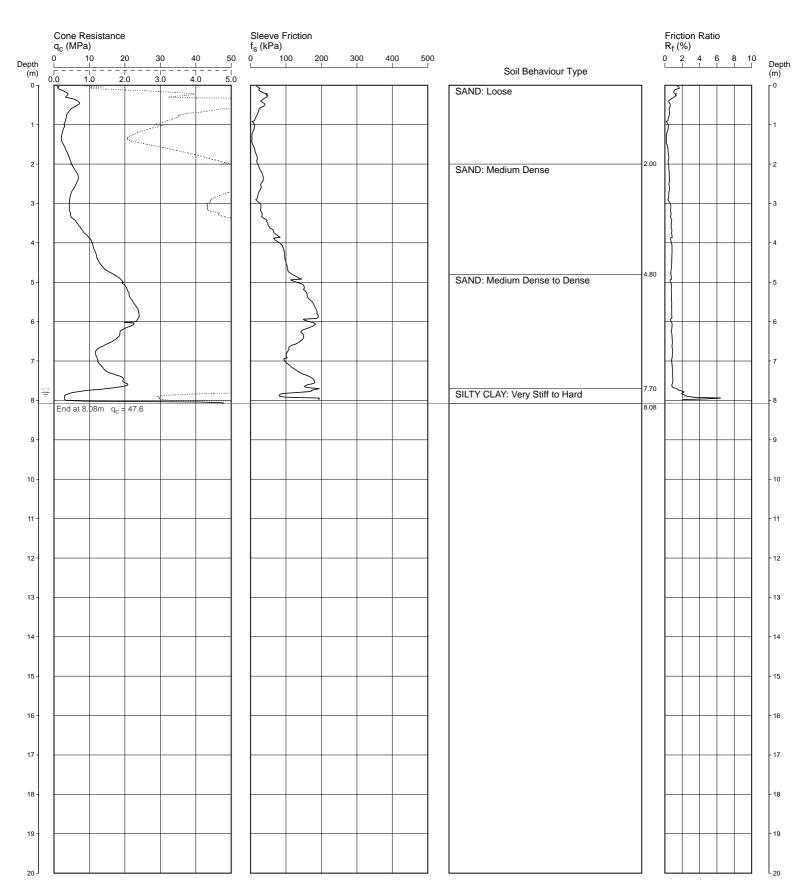
**REMARKS:** TEST DISCONTINUED DUE TO CONE TIP REFUSUAL; GROUNDWATER WAS OBSERVED AT 7.8 m DEPTH AFTER WITHDRAWAL OF RODS

Water depth after test: 7.80m depth (assumed)
File: P:\84944.01 - BELLEVUE HILL Cristophook School ECI\4.0 Field Work\CPT Results\CPT 109.CP5

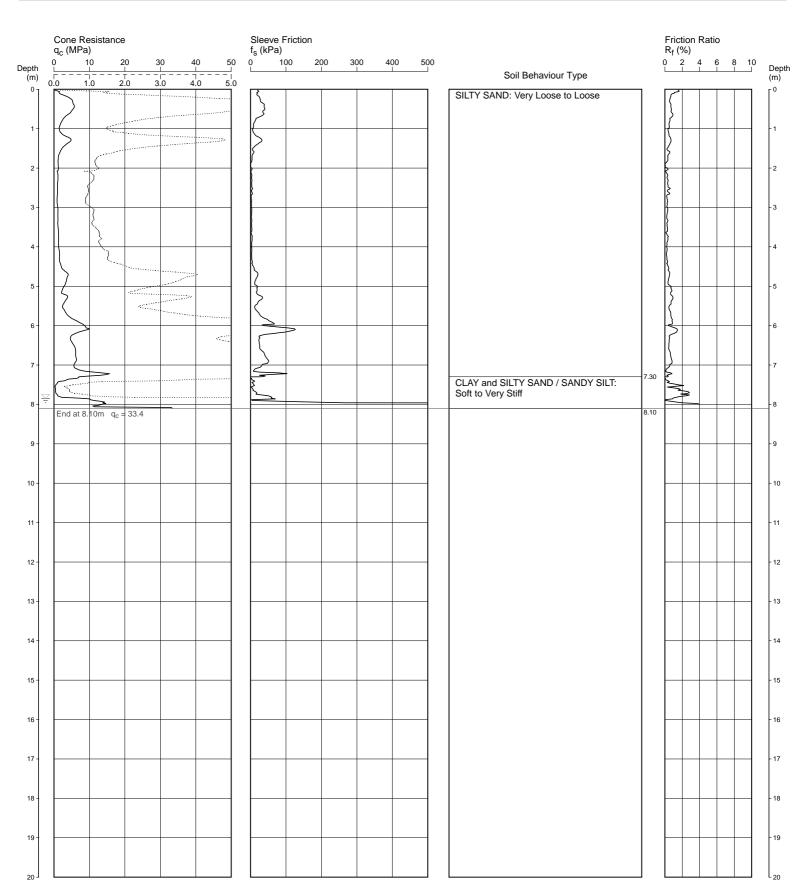
REMARKS: TEST DISCONTINUED DUE TO EXCESSIVE BEND ON POSSIBLE ROCK; GROUNDWATER WAS OBSERVEED AT 7.85 m DEPTH AFTER WITHDRAWAL OF RODS

Water depth after test: 7.85m depth (assumed)
File: P:\84944.01 - BELLEVUE HILL Cristophook School ECI\4.0 Field Work\CPT Results\CPT 110.CP5

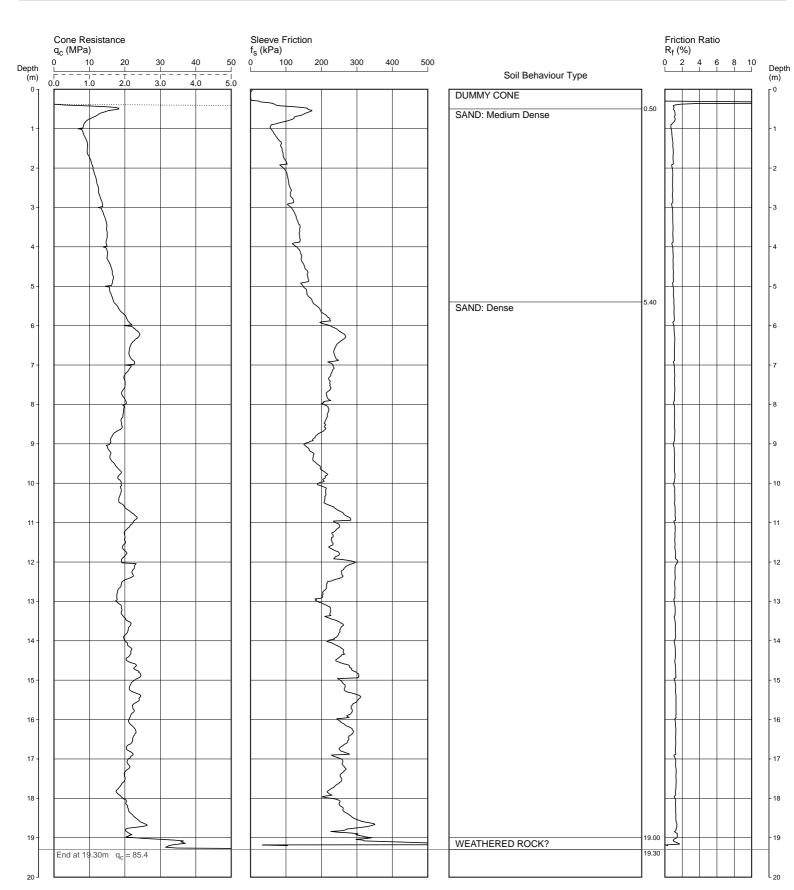
REMARKS: DUMMY CONE USED FROM 0.0 TO 0.5 m DEPTH, TEST DISCONTINUED DUE TO CONE TIP REFUSAL NO WATER OBSERVED IN CPT HOLE TO AT LEAST 10 m AFTER WITHDRAWAL OF RODS

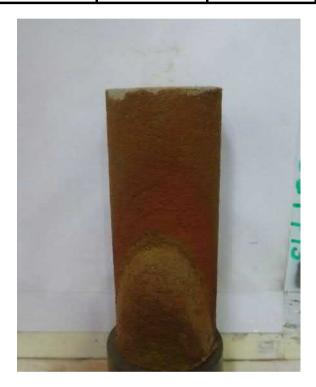
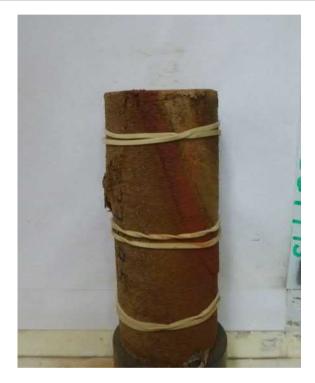
ι	JNIAX	IAL	COMP	RESSIVE S	TRENG	тн о	F ROCK RE	PORT	
Client:	Douglas Pa	artners			Source:	202 9-9.2m	ı		
Address:	PO Box 47	2 West R	yde NSW 1685	5	Sample Description:	Sandstone			
Project:	Cranbrook	School (8	34944.02)		Report No.:	S27795-U0	CS		
Job No.:	S17389				Lab No.:	S27795			
Test Proce	edure:			Rock strength tests - Determination of Rock strength tests - Determination of					
Sampling:	ng: Sampled by Client Date Sampled: Unknown								
Preparation	n:	Prepared	in accordance w	rith the test method					
Date '	Date Tested         28/09/2017         Machine Type         Matest         Sample Storage Conditions         Wrapped						Wrapped

Average Diameter (mm)	Specimen Height (mm)	Length/ Diameter Ratio	Specimen Condition	Description of Failure	Duration of Test (Sec)	Load at Fracture (kN)	Moisture Content at Time of Test (%)	Compressive Strength (MPa)
52.10	135.6	2.60	As received	Mixed mode	614	5	6.8	2.28

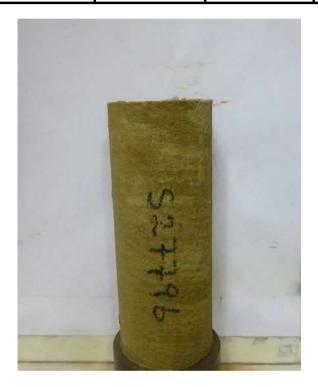
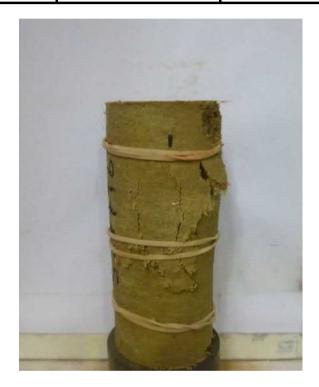
Ų	JNIAX	IAL CO	OMP	RESSIVE S	TRENG	тн о	F ROCK RE	PORT	
Client:	Douglas Pa	artners			Source:	203 11.74-	11.92m		
Address:	PO Box 47	PO Box 472 West Ryde NSW 1685				Sandstone			
Project:	Cranbrook	School (8494	4.02)		Report No.:	S27796-U	CS		
Job No.:	S17389				Lab No.:	S27796			
Test Proce	edure:			Rock strength tests - Determination of Rock strength tests - Determination of					
Sampling:	g: Sampled by Client Date Sampled: Unknown							Unknown	
Preparation	n:	Prepared in ac	cordance w	vith the test method					
Date '	Date Tested         28/09/2017         Machine Type         Matest         Sample Storage Conditions         Wrapped						Wrapped

Average Diameter (mm)	Specimen Height (mm)	Length/ Diameter Ratio	Specimen Condition	Description of Failure	Duration of Test (Sec)	Load at Fracture (kN)	Moisture Content at Time of Test (%)	Compressive Strength (MPa)
51.80	135.7	2.62	As received	Mixed mode	607	16	7.5	7.59

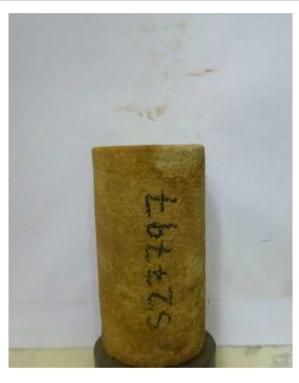
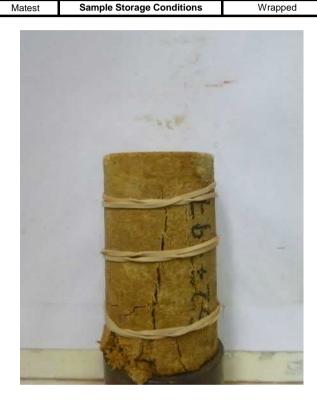
ι	JNIAX	IAL COMP	RESSIVE S	TRENG	TH OF	<b>ROCK RE</b>	PORT	
Client:	Douglas Pa	artners		Source:	204 20.1-20.2	'8m		
Address:	PO Box 47	'2 West Ryde NSW 168	35	Sample Description:	Sandstone			
Project:	Cranbrook	School (84944.02)		Report No.:	S27797-UCS			
Job No.:	S17389			Lab No.:	S27797			
Test Proce	edure:	AS4133 4.2.1  AS4133 4.2.2	Rock strength tests - Determination of Rock strength tests - Determination of					
Sampling:		Sampled by Client				Date Sampled:	Unknown	
Preparation	n:	Prepared in accordance	with the test method					
Date	Date Tested         28/09/2017         Machine Type         Matest         Sample Storage Conditions         Wrapped					Wrapped

Average Diameter (mm)	Specimen Height (mm)	Length/ Diameter Ratio	Specimen Condition	Description of Failure	Duration of Test (Sec)	Load at Fracture (kN)	Moisture Content at Time of Test (%)	Compressive Strength (MPa)
51.80	97.2	1.88	As received	Mixed mode	612	23	3.1	10.9

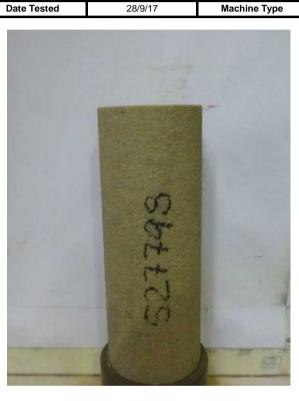
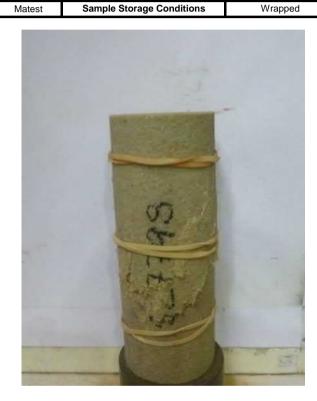
ι	JNIA	XIAL	COMPRESSIVE S	TRENG	TH O	F ROCK RE	PORT	
Client:	Douglas	Partners		Source:	205 22.78-2	23m		
Address:	PO Box 4	72 West R	Ryde NSW 1685	Sample Description:	Sandstone			
Project:	Cranbroo	k School (	84944.02)	Report No.:	S27798-UCS			
Job No.:	S17389			Lab No.:	S27798			
Test Procedure:  AS4133 4.2.1 Rock strength tests - Determination of uniaxial compressive strength - Rock Strength >50MPa  AS4133 4.2.2 Rock strength tests - Determination of uniaxial compressive strength - Rock Strength < 50 Mpa								
Sampling:		Sampled	by Client			Date Sampled:	Unknown	
Preparatio	ation: Prepared in accordance with the test method

Average Diameter (mm)	Specimen Height (mm)	Length/ Diameter Ratio	Specimen Condition	Description of Failure	Duration of Test (Sec)	Load at Fracture (kN)	Moisture Content at Time of Test (%)	Compressive Strength (MPa)
51.80	134.8	2.60	As received	Mixed mode	614	24	9.4	11.3

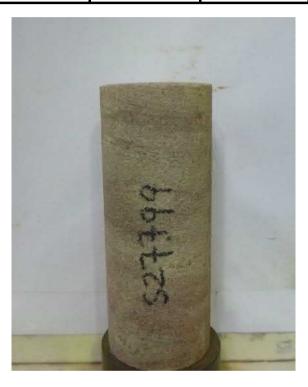
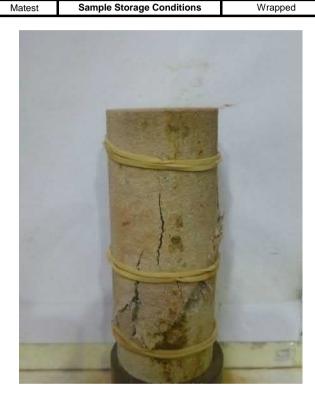
l	UNIAXIAL COMPRESSIVE STRENGTH OF ROCK REPORT								
Client:	Douglas Pa	artners		Source:	208 24-24.2	2m			
Address:	PO Box 47	'2 West Ryde NSW 168	35	Sample Description:	Sandstone				
Project:	Cranbrook	School (84944.02)		Report No.:	S27799-UCS				
Job No.:	S17389			Lab No.:	S27799				
Test Proce	AS4133 4.2.1 Rock strength tests - Determination of uniaxial compressive strength - Rock Strength >50MPa  AS4133 4.2.2 Rock strength tests - Determination of uniaxial compressive strength - Rock Strength < 50 Mpa								
Sampling:	Sampling: Sampled by Client Date Sampled: Unknown								
Preparation	Preparation: Prepared in accordance with the test method								
Date	Date Tested         28/09/2017         Machine Type         Matest         Sample Storage Conditions         Wrapped

Average Diameter (mm)	Specimen Height (mm)	Length/ Diameter Ratio	Specimen Condition	Description of Failure	Duration of Test (Sec)	Load at Fracture (kN)	Moisture Content at Time of Test (%)	Compressive Strength (MPa)
51.70	134.5	2.60	As received	Mixed mode	606	26	4.0	12.4

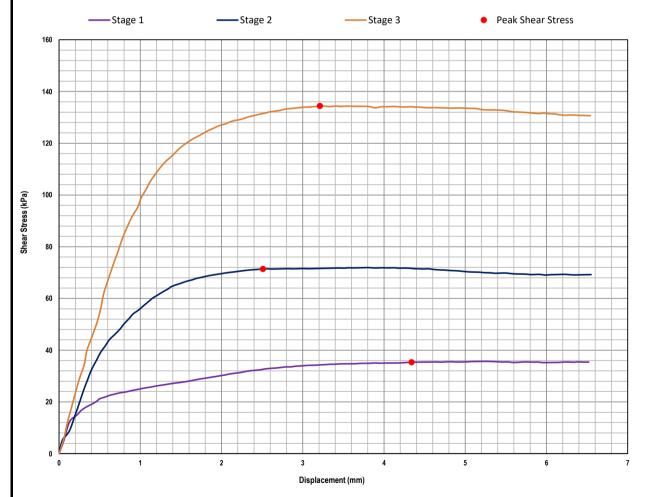
## Peak Shear Stress / Horizontal Displacement

#### SHEAR STRENGTH BY DIRECT SHEAR REPORT AS1289 6.2.2 Client: Douglas Partners Source: Sample 1 PO Box 472 West Ryde NSW 1685 Address: Sample Description: SAND Project: 84944 02 Report No.: S30724-DS Job No.: S18046 Lab No.: S30724 Test Procedure: AS1289 6,2,2 Soil strength and consolidation tests - Determination of the shear strength of a soil - Direct shear test using a shear box Sampling: Sampled by Client Date Sampled: 08.02.18 Prepared in accordance with the test method Preparation: **Test Details** Remoulding Details: 95% Standard Compaction @ 100% Optimum Moisture Content Date Tested: 27.02.18 100mm square Size of Shear Box (mm) **Test Parameter** Stage 1 Stage 2 Stage 3 Stage 4 Stage 5 Stage 6 Specimen Dimensions (mm): 100 x 100 100 x 100 100 x 100 Rate of Strain (mm/min): 0.05 0.05 0.05 Placement Moisture Content (%): 14.9 14.9 14.9 Placement Wet Density (t/m3): 1.86 1.86 1.86 Placement Dry Density (t/m3): 1.62 1.62 1.62 **Peak Values** Normal Stress at Nominated Displacement (kPa) Shear Stress at Nominated Displacement (kPa) Normal Stress at Peak Shear Stress (kPa) 50.0 100.0 200.0 \_ Peak Shear Stress (kPa) 35.3 71.4 134.4 Normal Stress at Constant Volume (kPa) Shear Stress at Constant Volume (kPa) **Residual Values** Normal Stress at Nominated Displacement (kPa) Shear Stress at Nominated Displacement (kPa) Normal Stress at Residual Shear Stress (kPa) Residual Shear Stress (kPa) Normal Stress at Constant Volume (kPa) Shear Stress at Constant Volume (kPa) **Failure Envelopes** Peak Values Residual Values Friction Angle (°) At Displacement Cohesion (kPa) \_ \_ Correlation \_ \_ Friction Angle (°) 33.3 \_ **Shear Stress** Cohesion (kPa) 3.8 0.9994 Correlation Friction Angle (°) Cohesion (kPa) At Constant Volume Correlation -

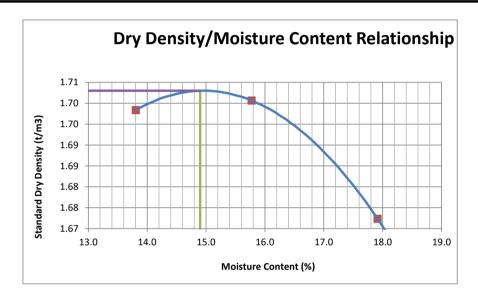
DRY DENSITY / OPTIMUM MOISTURE CONTENT REPORT		
Client:	Douglas Partners	Source:	Sample 1
Address:	PO Box 472 West Ryde NSW 1685	Sample Description:	SAND

Maximum Dry Density (t/m³)	1.703
Optimum Moisture Content (%)	14.9
	•
Percentage Oversize on 19mm sieve (%)	0
Percentage Oversize on 37.5mm sieve (%)	0

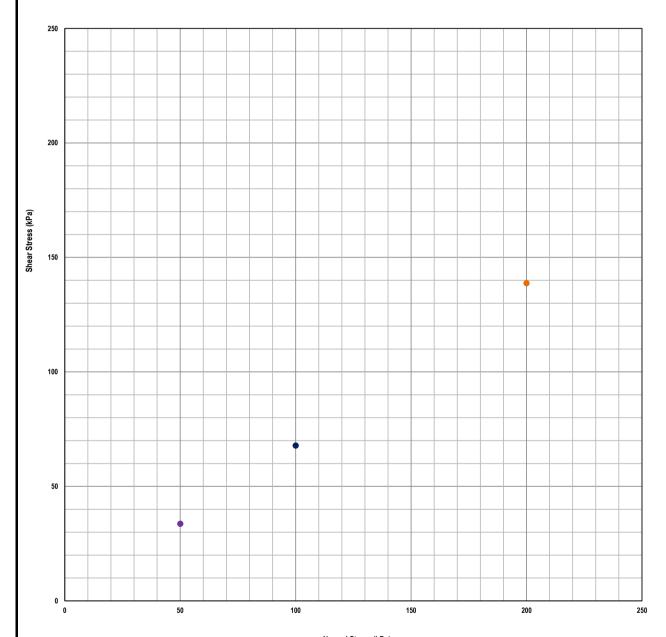
## Peak Shear Stress / Normal Stress

#### SHEAR STRENGTH BY DIRECT SHEAR REPORT AS1289 6.2.2 Client: Douglas Partners Source: Sample 2 PO Box 472 West Ryde NSW 1685 Address: Sample Description: SAND Project: 84944 02 Report No.: S30725-DS Job No.: S18046 Lab No.: S30725 Test Procedure: AS1289 6,2,2 Soil strength and consolidation tests - Determination of the shear strength of a soil - Direct shear test using a shear box Sampling: Sampled by Client Date Sampled: 08.02.18 Prepared in accordance with the test method Preparation: **Test Details** Remoulding Details: 95% Standard Compaction @ 100% Optimum Moisture Content Date Tested: 22.02.18 100mm square Size of Shear Box (mm) **Test Parameter** Stage 1 Stage 2 Stage 3 Stage 4 Stage 5 Stage 6 Specimen Dimensions (mm): 100 x 100 100 x 100 100 x 100 Rate of Strain (mm/min): 0.05 0.05 0.05 Placement Moisture Content (%): 13.6 13.6 13.6 Placement Wet Density (t/m3): 1.86 1.86 1.86 Placement Dry Density (t/m3): 1.64 1.64 1.64 **Peak Values** Normal Stress at Nominated Displacement (kPa) Shear Stress at Nominated Displacement (kPa) Normal Stress at Peak Shear Stress (kPa) 50.0 100.0 200.0 \_ Peak Shear Stress (kPa) 33.7 67.8 138.7 Normal Stress at Constant Volume (kPa) Shear Stress at Constant Volume (kPa) **Residual Values** Normal Stress at Nominated Displacement (kPa) Shear Stress at Nominated Displacement (kPa) Normal Stress at Residual Shear Stress (kPa) Residual Shear Stress (kPa) Normal Stress at Constant Volume (kPa) Shear Stress at Constant Volume (kPa) **Failure Envelopes** Peak Values Residual Values Friction Angle (°) At Displacement Cohesion (kPa) \_ \_ Correlation \_ \_ Friction Angle (°) 34.6 \_ **Shear Stress** Cohesion (kPa) 0.0 1.0000 Correlation Friction Angle (°) Cohesion (kPa) At Constant Volume Correlation -
