Report on Additional Geotechnical Investigation

Cranbrook School ECI Victoria Road, Bellevue Hill

> Prepared for Cranbrook School

Project 84944.02 October 2018

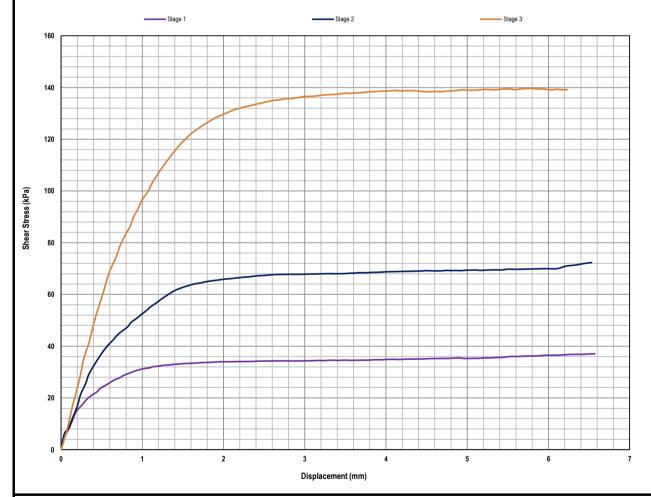
## Peak Shear Stress / Horizontal Displacement

#### SHEAR STRENGTH BY DIRECT SHEAR REPORT AS1289 6.2.2 Client: Douglas Partners Source: Sample 2 PO Box 472 West Ryde NSW 1685 Address: Sample Description: SAND Project: 84944 02 Report No.: S30725-DS Job No.: S18046 Lab No.: S30725 Test Procedure: AS1289 6,2,2 Soil strength and consolidation tests - Determination of the shear strength of a soil - Direct shear test using a shear box Sampling: Sampled by Client Date Sampled: 08.02.18 Prepared in accordance with the test method Preparation: **Test Details** Remoulding Details: 95% Standard Compaction @ 100% Optimum Moisture Content Date Tested: 22.02.18 100mm square Size of Shear Box (mm) **Test Parameter** Stage 1 Stage 2 Stage 3 Stage 4 Stage 5 Stage 6 Specimen Dimensions (mm): 100 x 100 100 x 100 100 x 100 Rate of Strain (mm/min): 0.05 0.05 0.05 Placement Moisture Content (%): 13.6 13.6 13.6 Placement Wet Density (t/m3): 1.86 1.86 1.86 Placement Dry Density (t/m3): 1.64 1.64 1.64 **Peak Values** Normal Stress at Nominated Displacement (kPa) Shear Stress at Nominated Displacement (kPa) Normal Stress at Peak Shear Stress (kPa) 50.0 100.0 200.0 \_ Peak Shear Stress (kPa) 33.7 67.8 138.7 Normal Stress at Constant Volume (kPa) Shear Stress at Constant Volume (kPa) **Residual Values** Normal Stress at Nominated Displacement (kPa) Shear Stress at Nominated Displacement (kPa) Normal Stress at Residual Shear Stress (kPa) Residual Shear Stress (kPa) Normal Stress at Constant Volume (kPa) Shear Stress at Constant Volume (kPa) **Failure Envelopes** Peak Values Residual Values Friction Angle (°) At Displacement Cohesion (kPa) \_ \_ Correlation \_ \_ Friction Angle (°) 34.6 \_ **Shear Stress** Cohesion (kPa) 0.0 1.0000 Correlation Friction Angle (°) Cohesion (kPa) At Constant Volume Correlation -

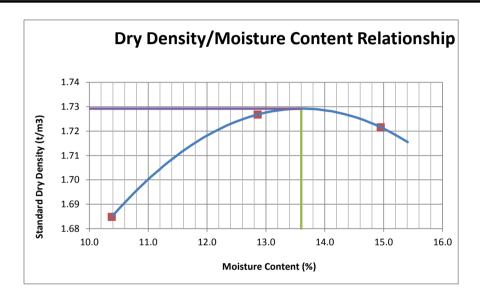
DRY DENSITY / OPTIMUM MOISTURE CONTENT REPORT				
Client:	Douglas Partners	Source:	Sample 2	
Address:	PO Box 472 West Ryde NSW 1685	Sample Description:	SAND	
Project:	84944 02	Report No:	S30725-MDD	
Job No:	S18046	Lab No:	S30725

Maximum Dry Density (t/m³)	1.729
Optimum Moisture Content (%)	13.6
Percentage Oversize on 19mm sieve (%)	0
Percentage Oversize on 37.5mm sieve (%)	0

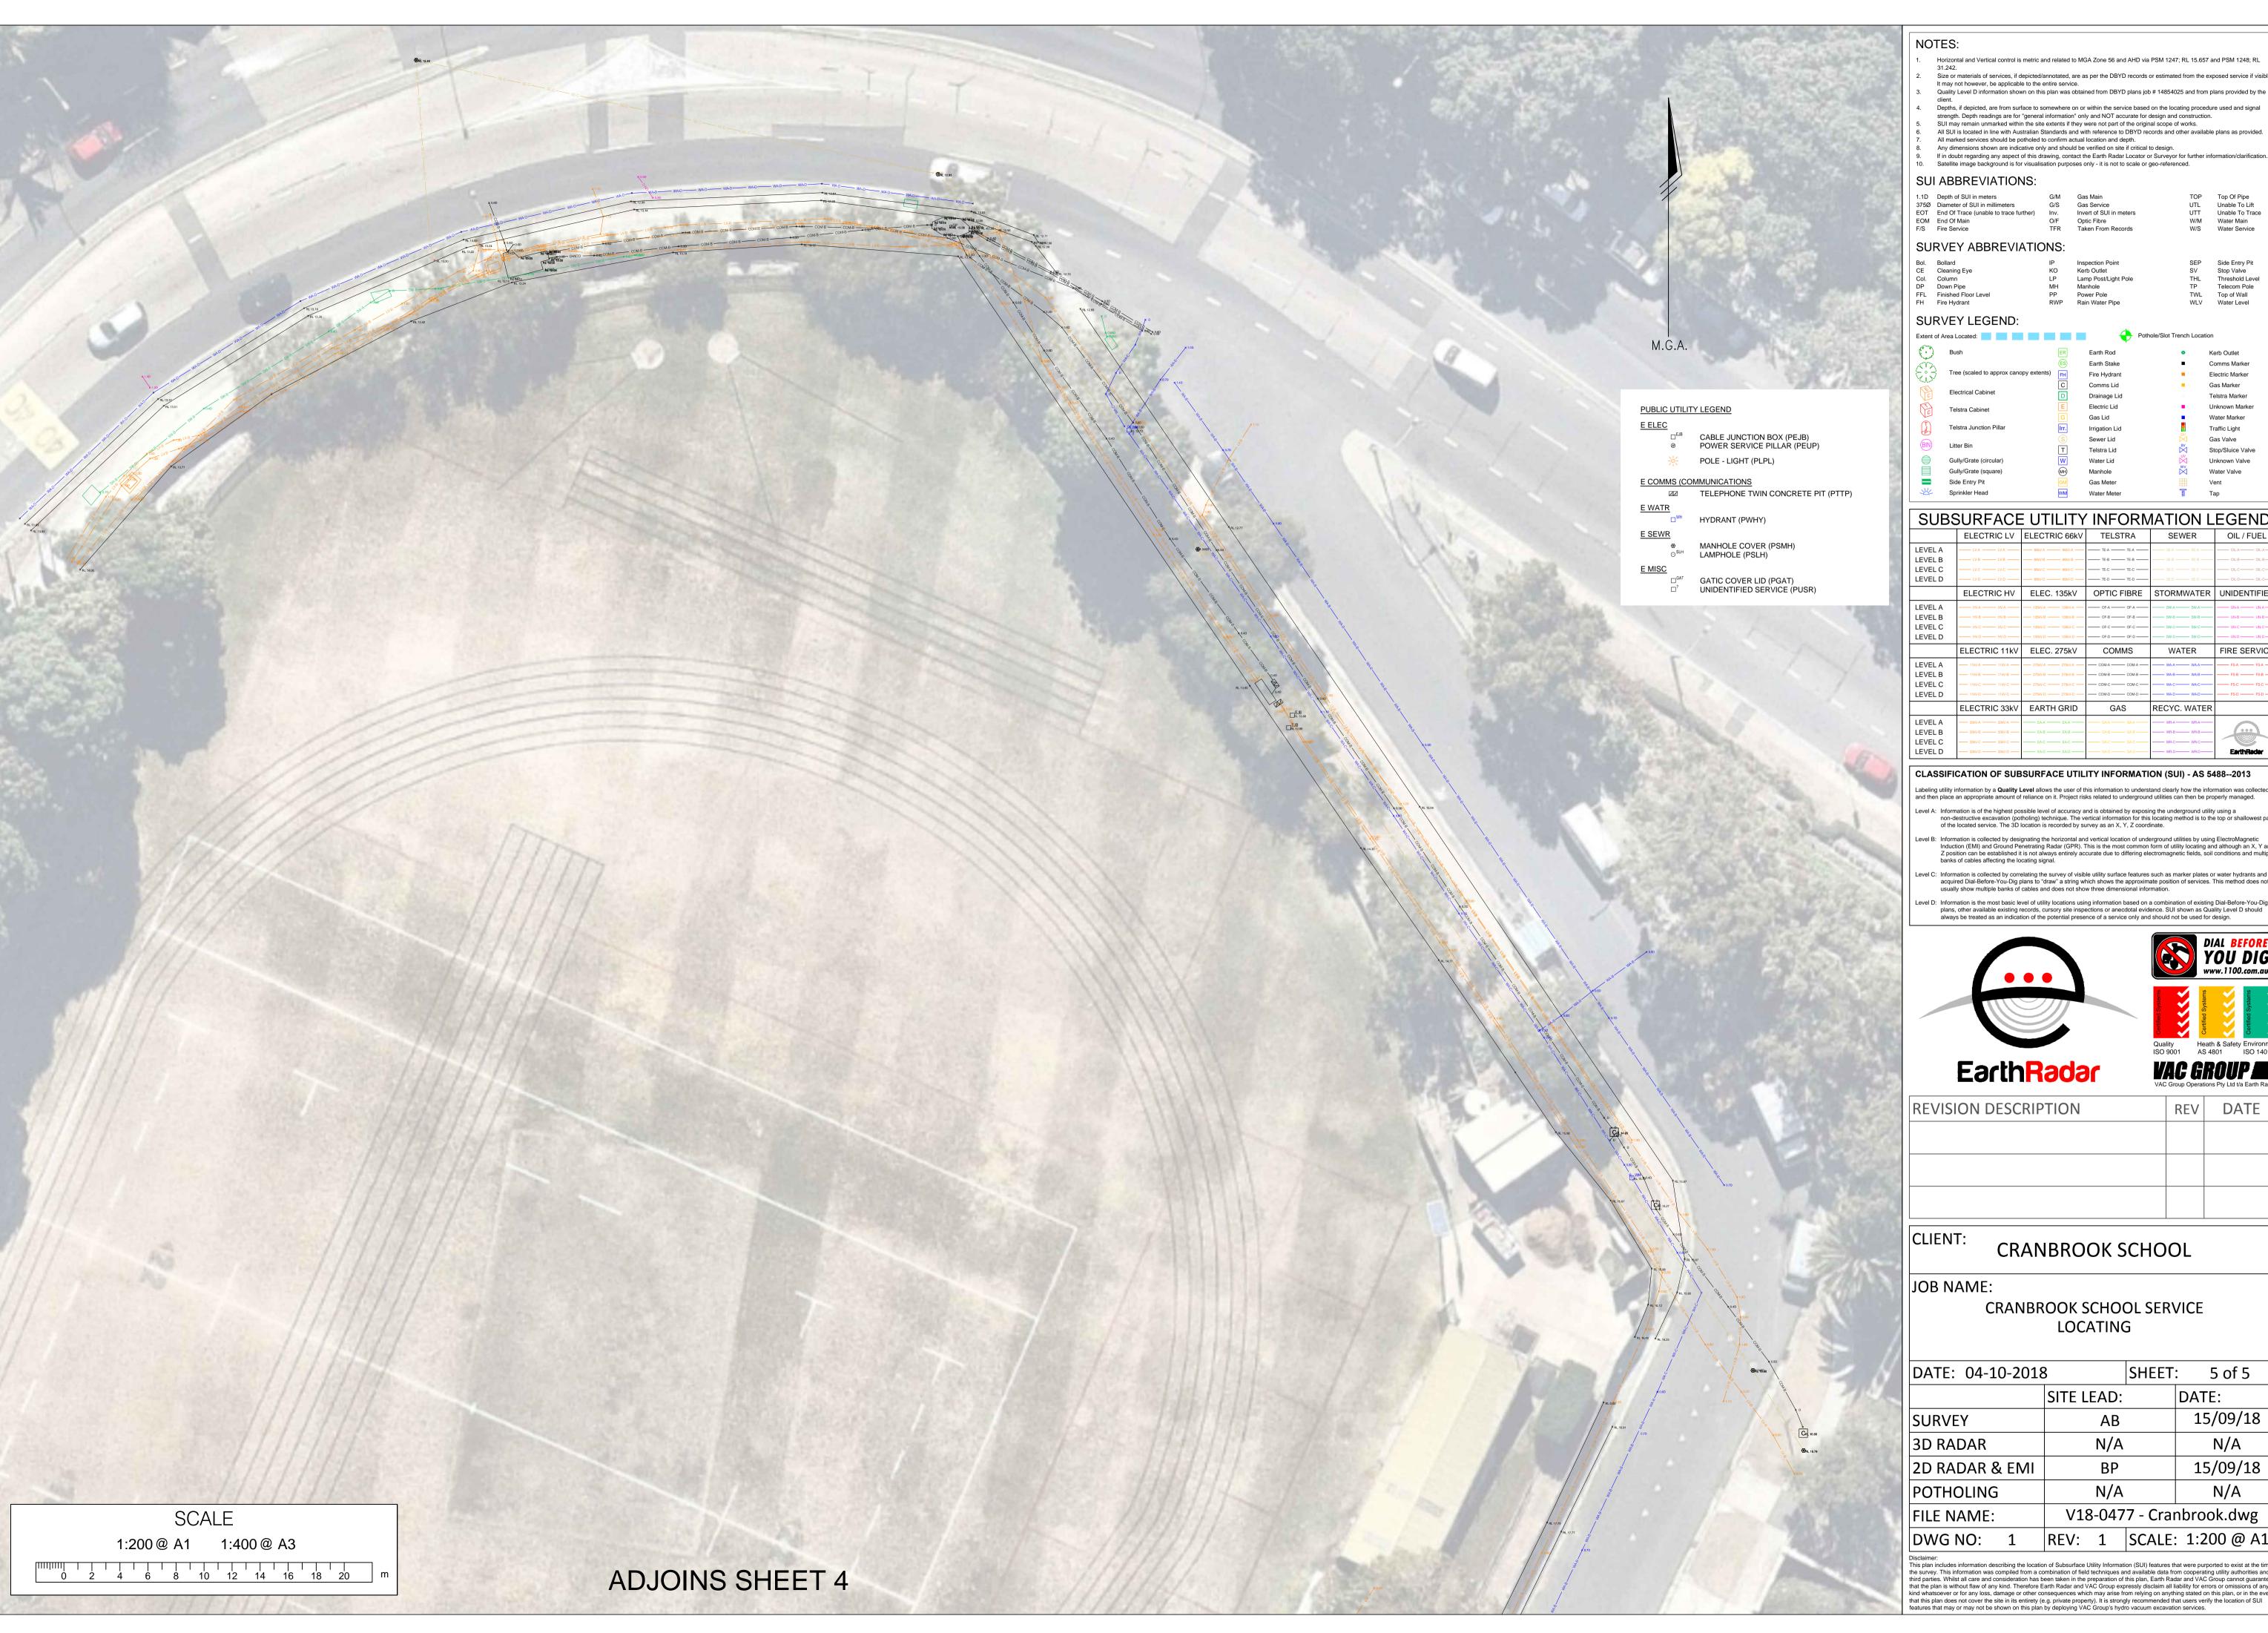
Appendix F - Utilities Survey

Horizontal and Vertical control is metric and related to MGA Zone 56 and AHD via PSM 1247; RL 15.657 and PSM 1248; RL

- Size or materials of services, if depicted/annotated, are as per the DBYD records or estimated from the exposed service if visible.
- Depths, if depicted, are from surface to somewhere on or within the service based on the locating procedure used and signal
